**Building and Facility Assessment
Panorama Community School District
High School / Middle School
701 W Main St, Panora, IA 50216**

February 27, 2025

Project: #25003 Panorama CSD Envelope Review

Purpose: Assessment Review of Elementary & High School / Middle School Envelopes and Systems

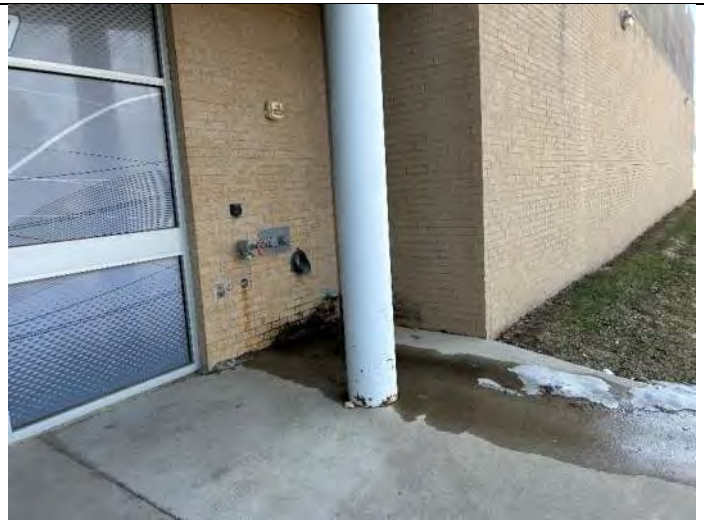
Elevation 1: Water/algae damage at FDC.

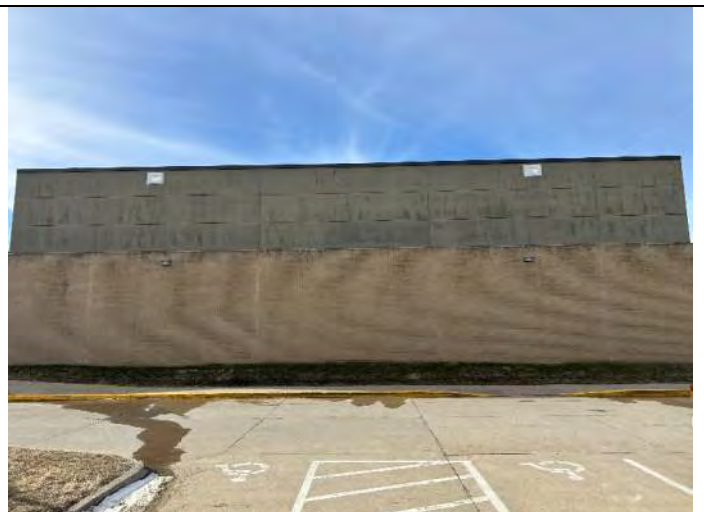
Elevation 2: EIFS above brick has failed.

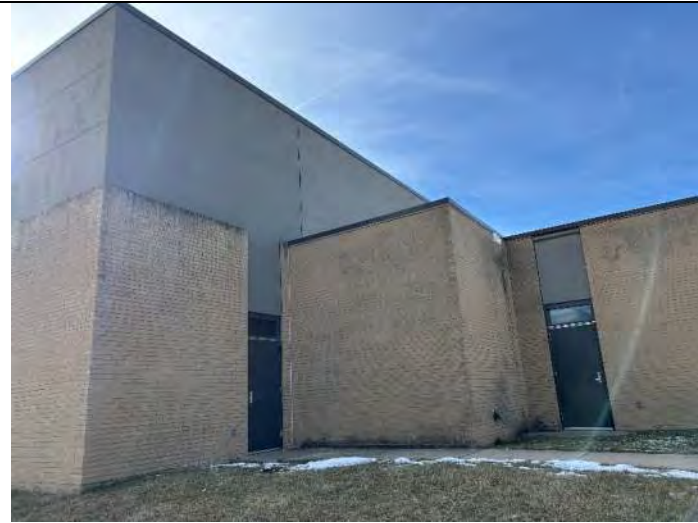
Elevation 2/3: EIFS failed, brick is algae stained.

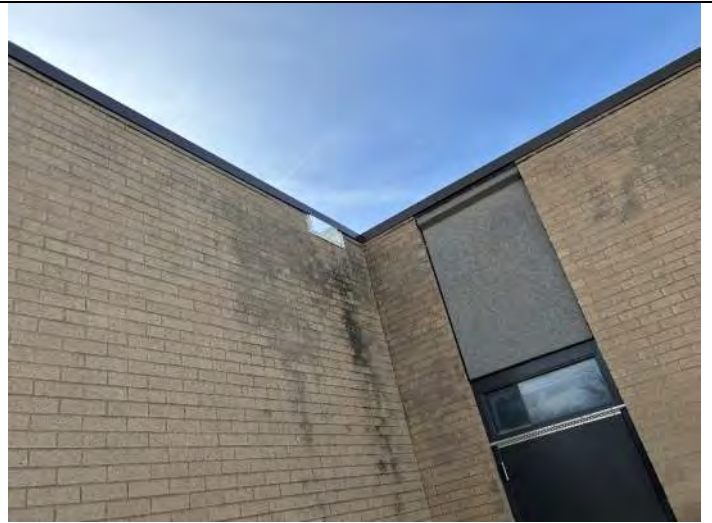
Elevation 3: Algae stain below scupper.

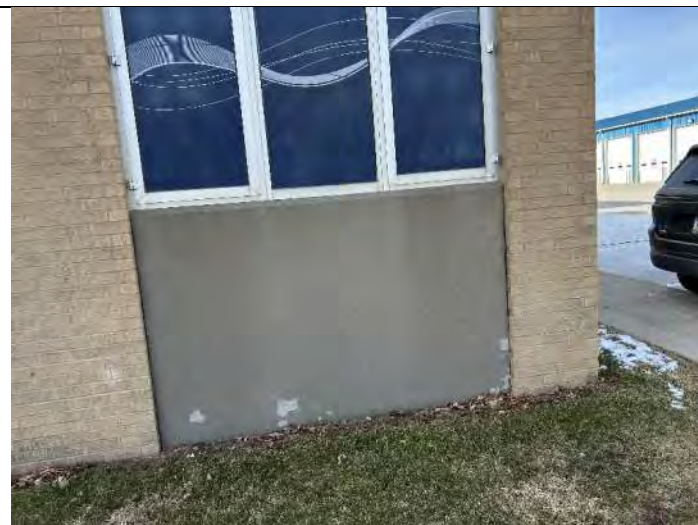
Elevation 3: EIFS below windows failing.

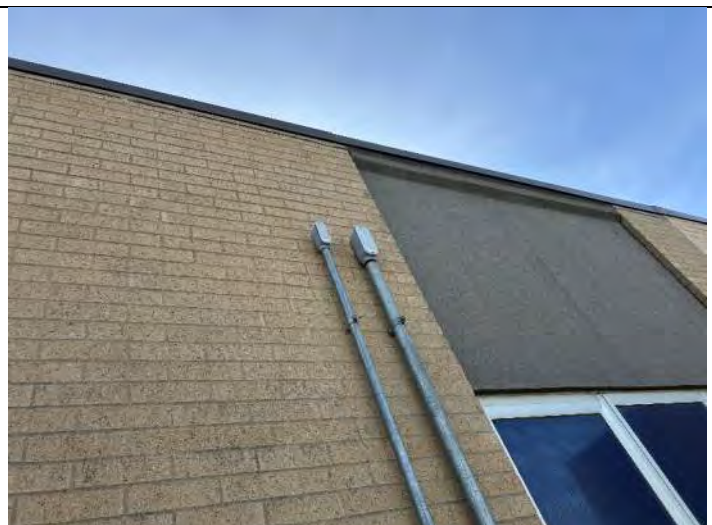
Elevation 3: Sealant needed at conduit penetrations.

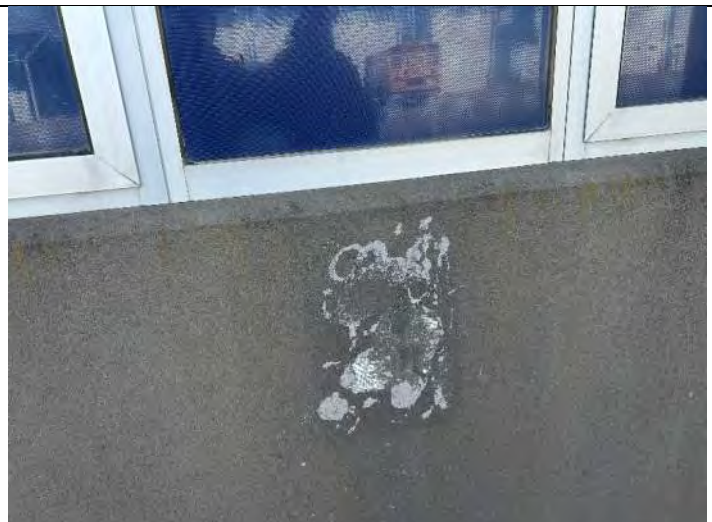
Elevation 3: EIFS needs repaired.

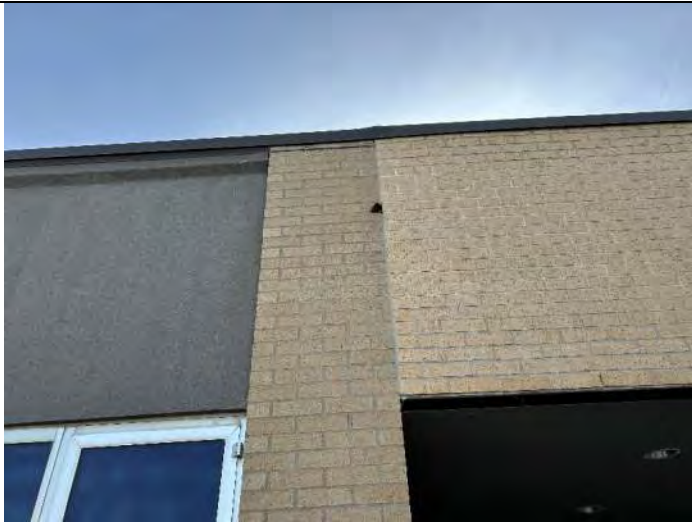
Elevation 3: Broken brick needs replaced.

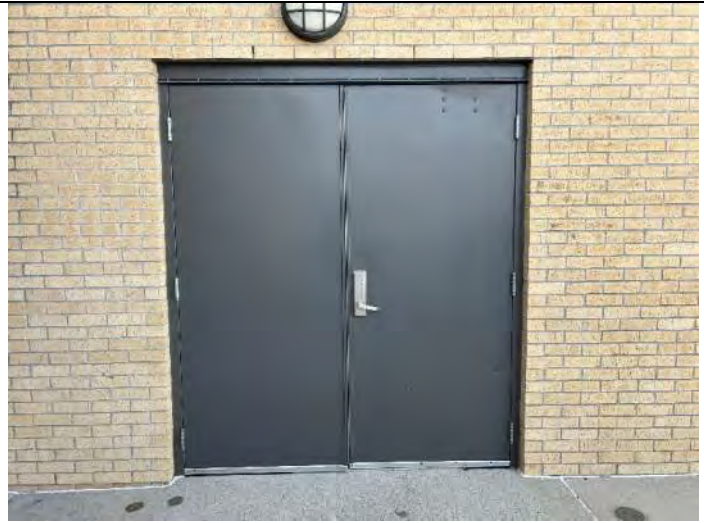
Elevation 4: HM door into weight room needs replaced.

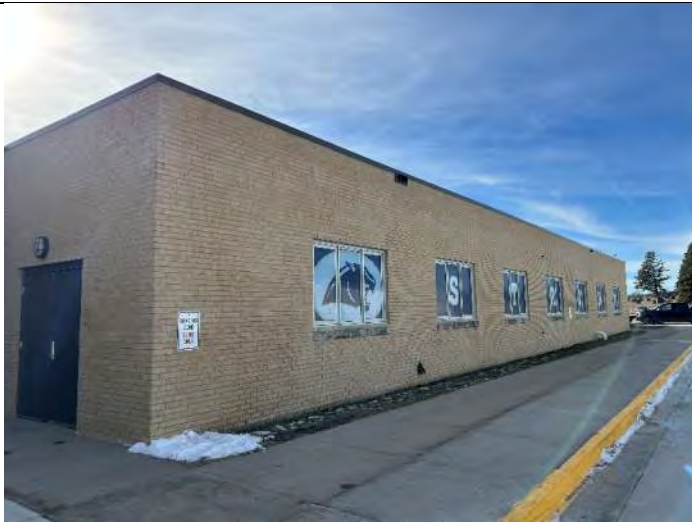
Elevation 4: Sill block is algae stained.

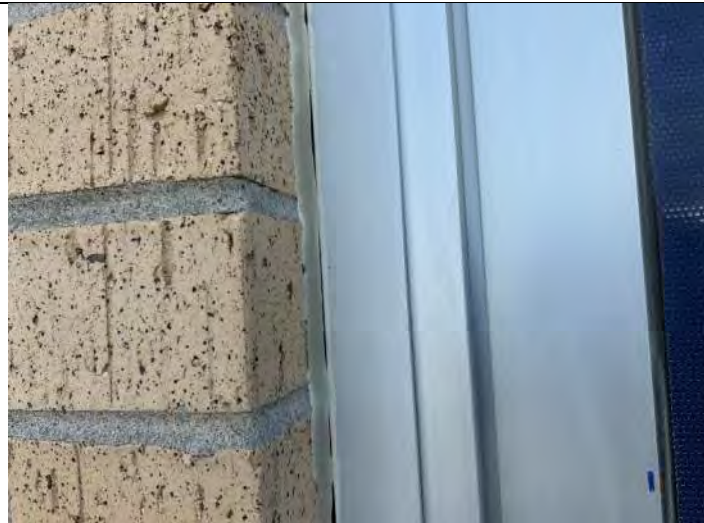
Elevation 4: Window sealant failed typically.

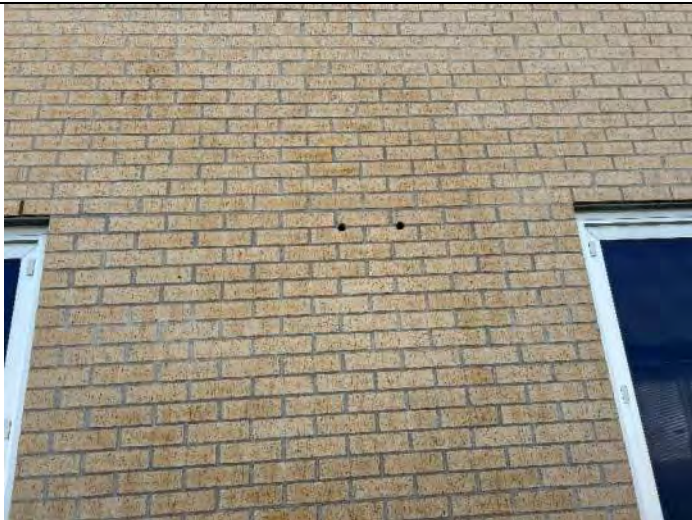
Elevation 4: Grout holes in brick.

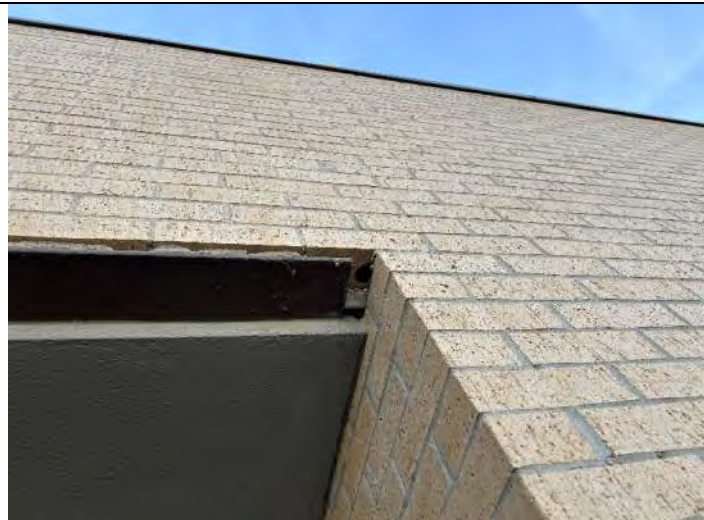
Elevation 4: Repair mortar at entry opening.

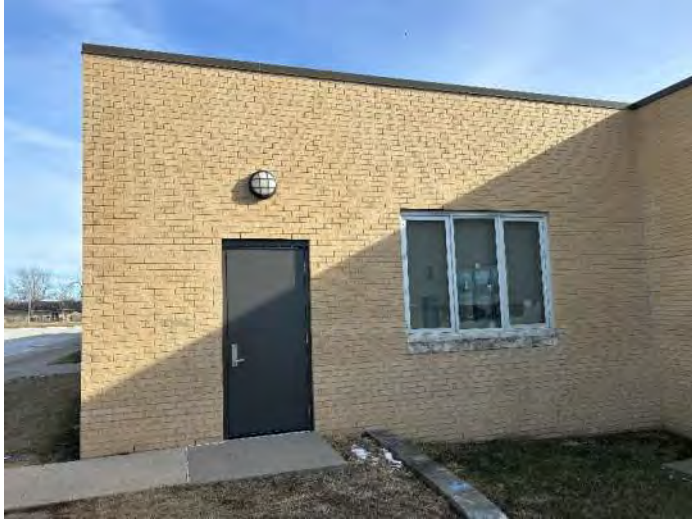
Elevation 4: Clean algae from sills and wall.

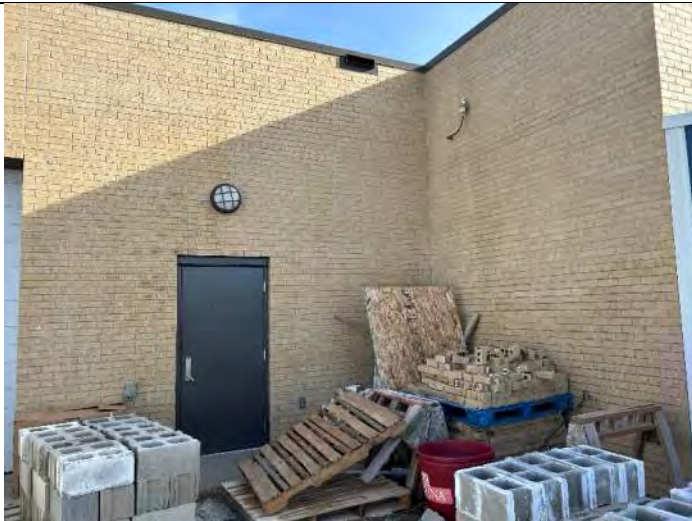
Elevation 4: HM door needs replaced and resealed.

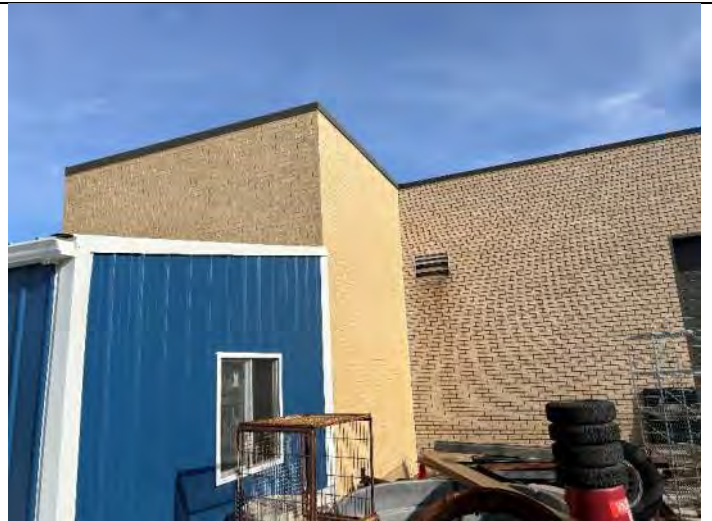
Elevation 5: May want to flash over shed.

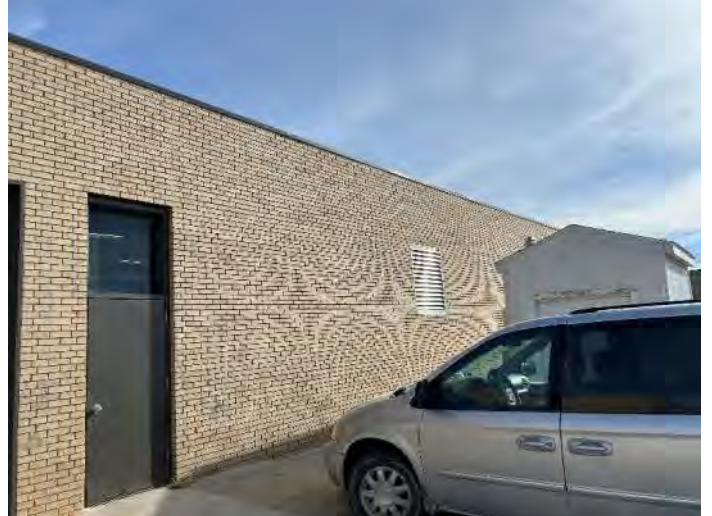
Elevation 5: Replace HM door.

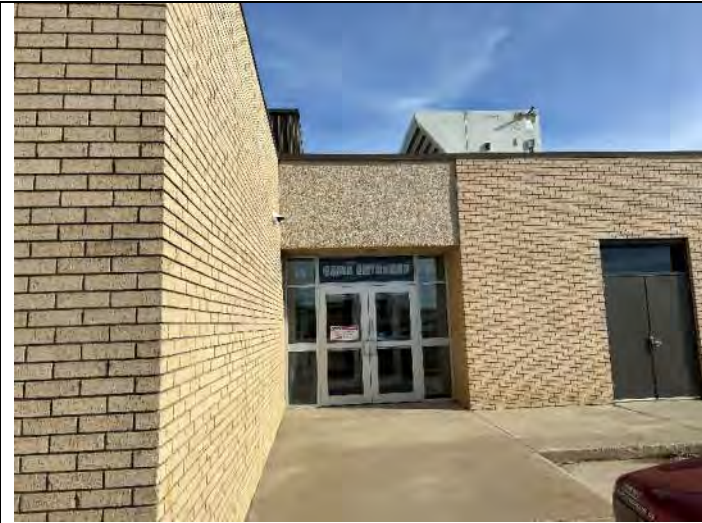
Elevation 5: Replace sealant at stone panel and door.

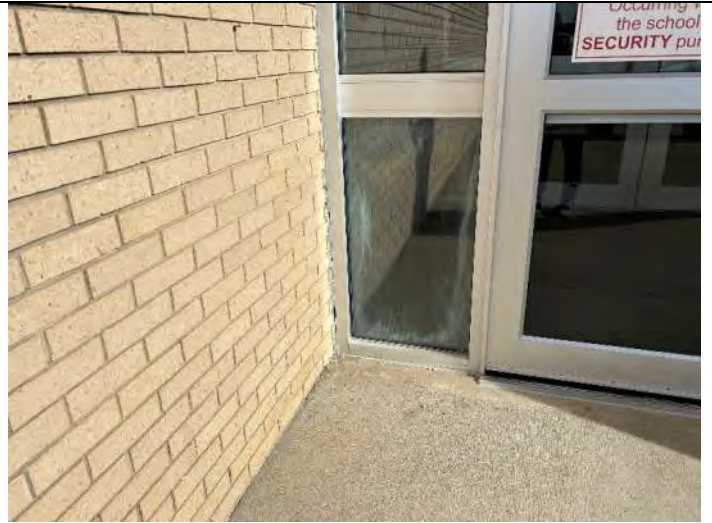
Elevation 6: Replace sealant at door frame.

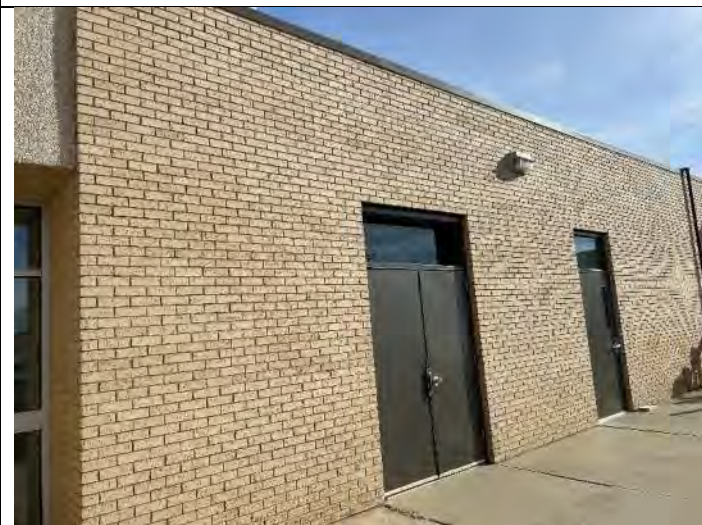
Elevation 6: Replace HM doors.

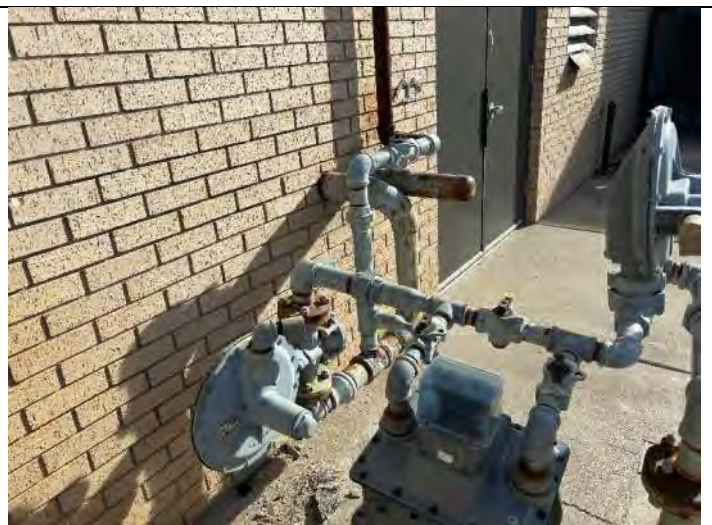
Elevation 6: Seal pipe penetrations.

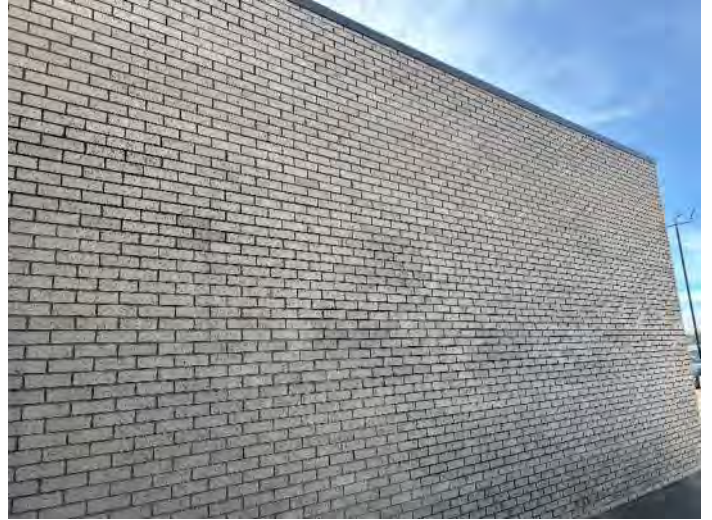
Elevation 7: No issue found here.

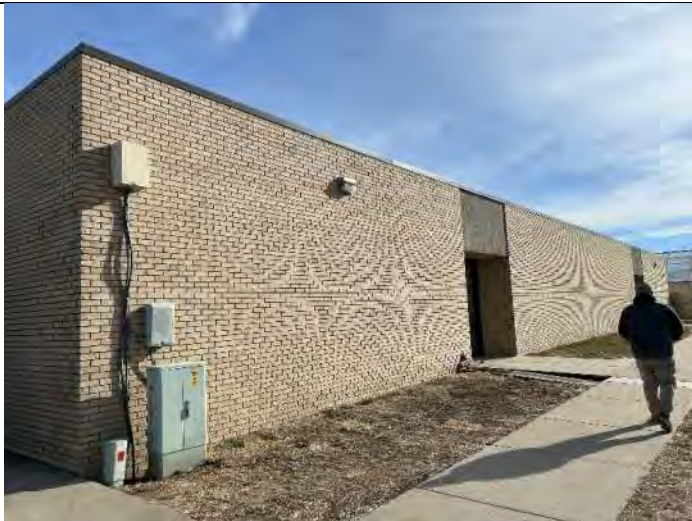
Elevation 7: No weeps in brick wall.

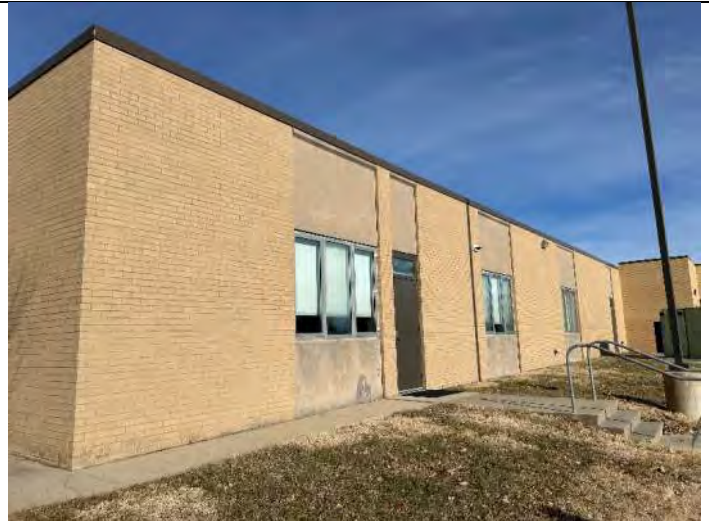
Elevation 9: EIFS needs repair, reseal windows & doors.

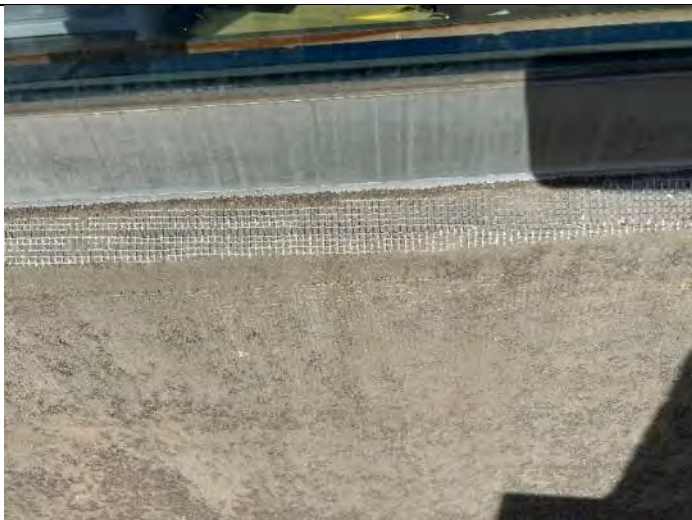
Elevation 9: EIFS needs repair.

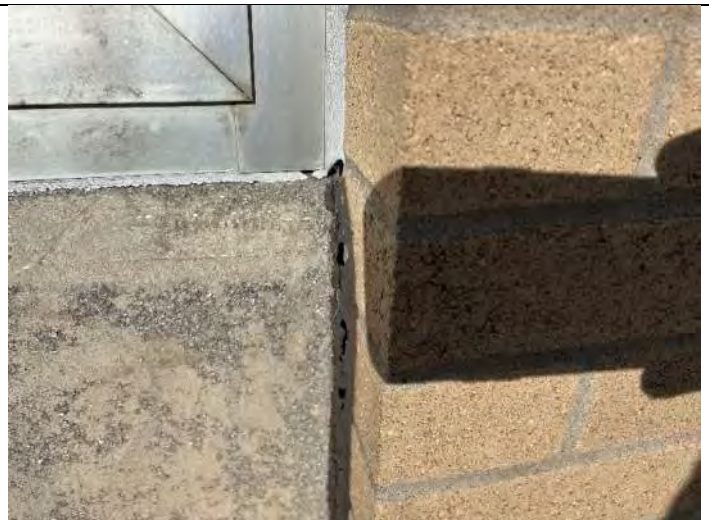
Elevation 9: Sealant at EIFS and window are failed.

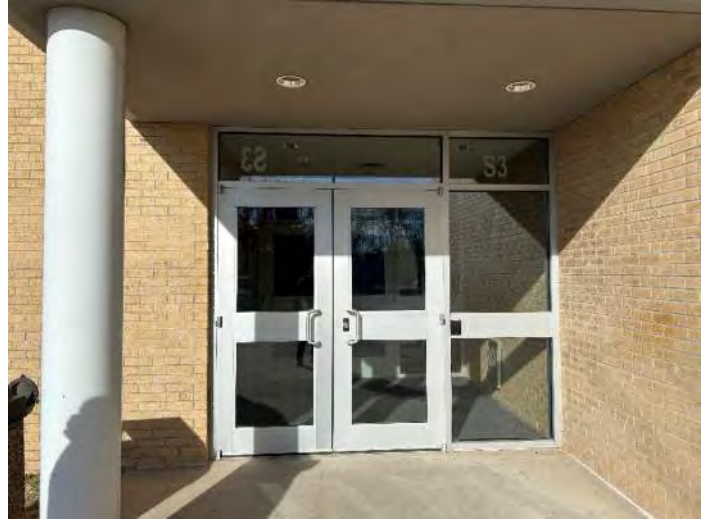
Elevation 1-0: West door hinges appear misaligned.

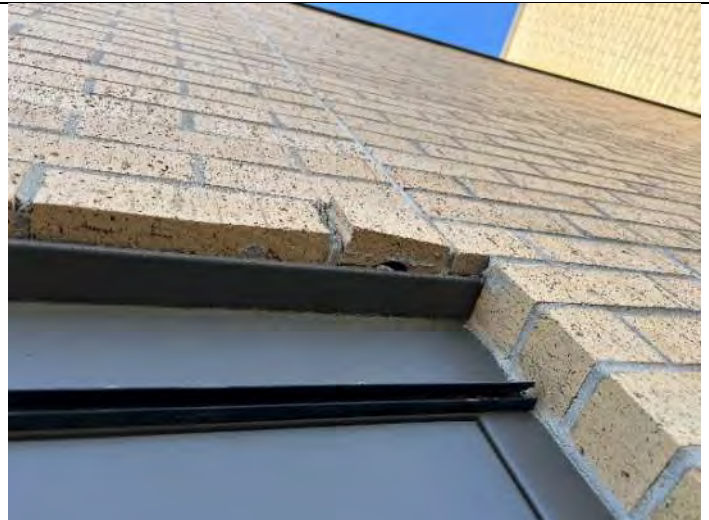
Elevation 11: Repair broken brick above door.

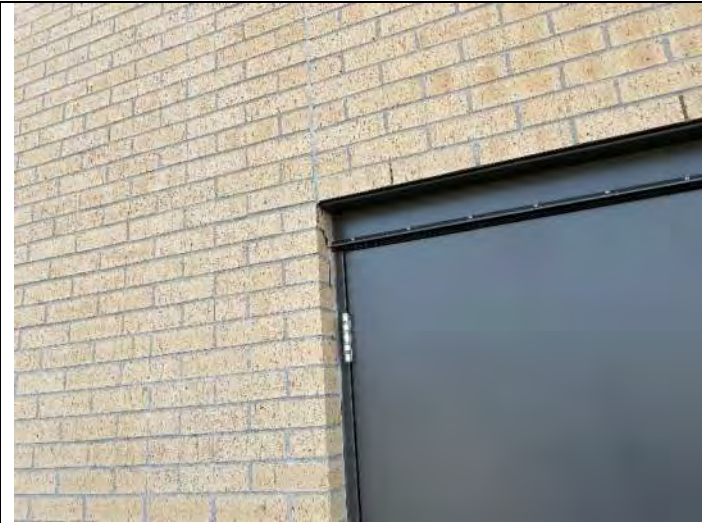
Elevation 11: Cracked brick at door head/jamb.

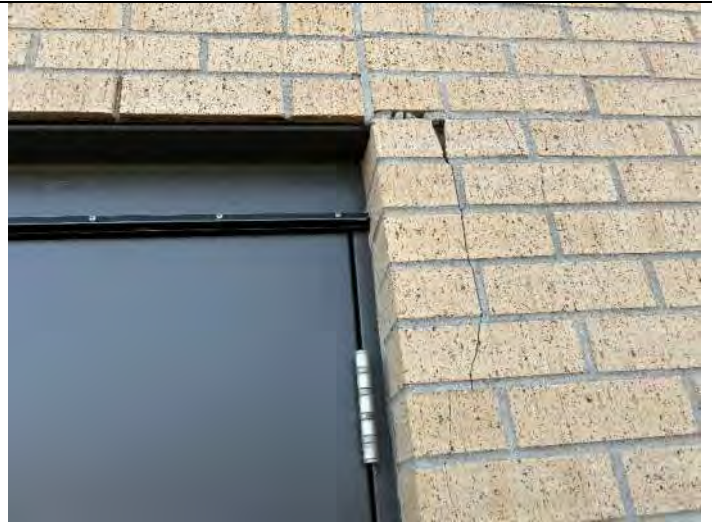
Elevation 11: Cracked brick at door head/jamb.

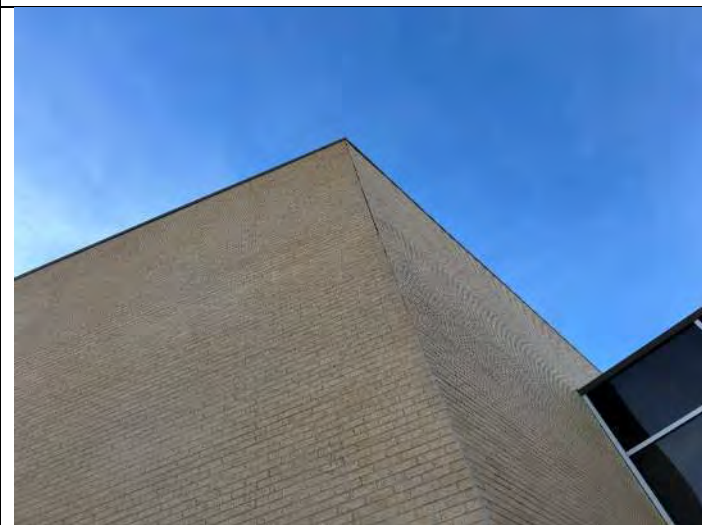
Elevation 11: Replace grout at corner with sealant.

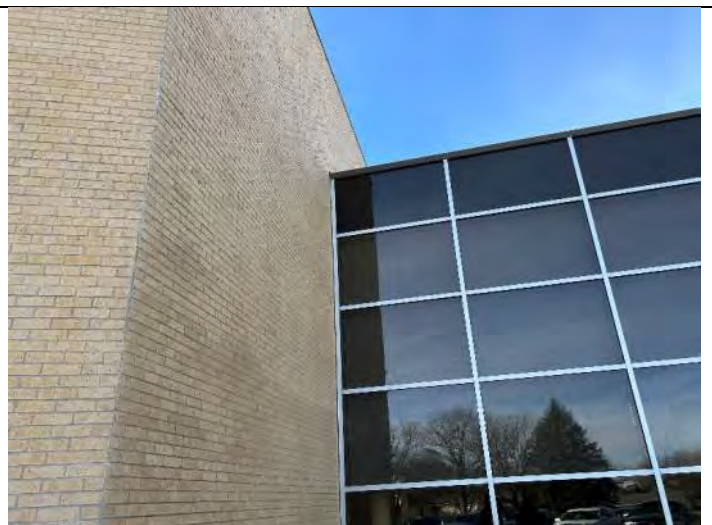
Elevation 12: Check sealant at curtainwall/brick.

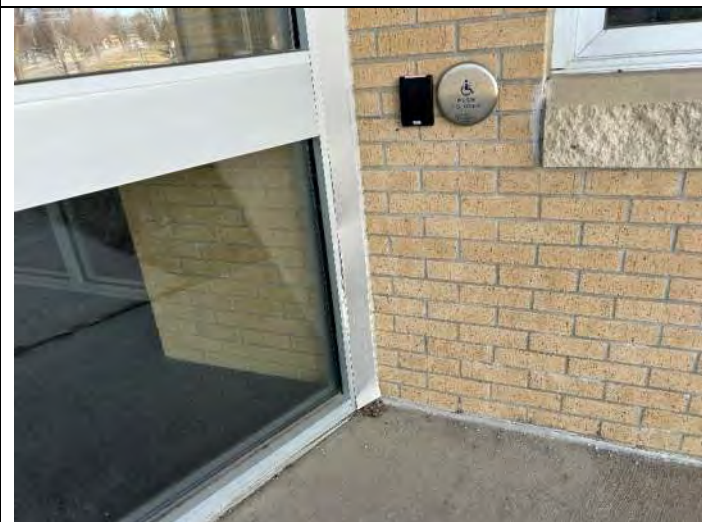
Elevation 12: Replace damaged aluminum metal.

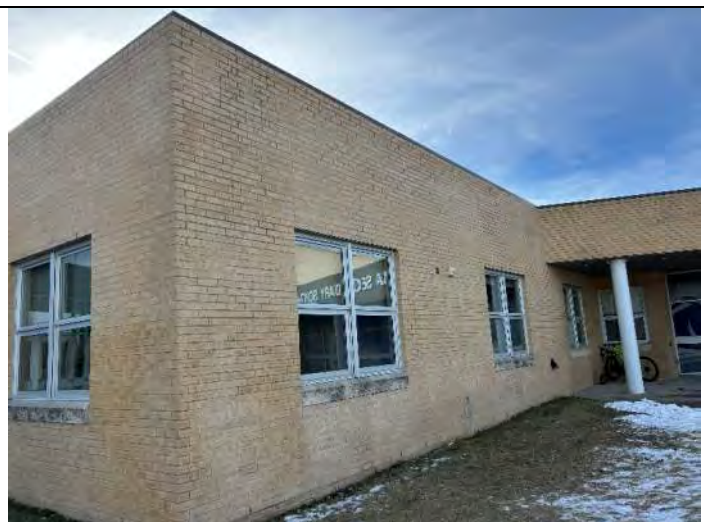
Elevation 12: Brick wall has moisture in it.

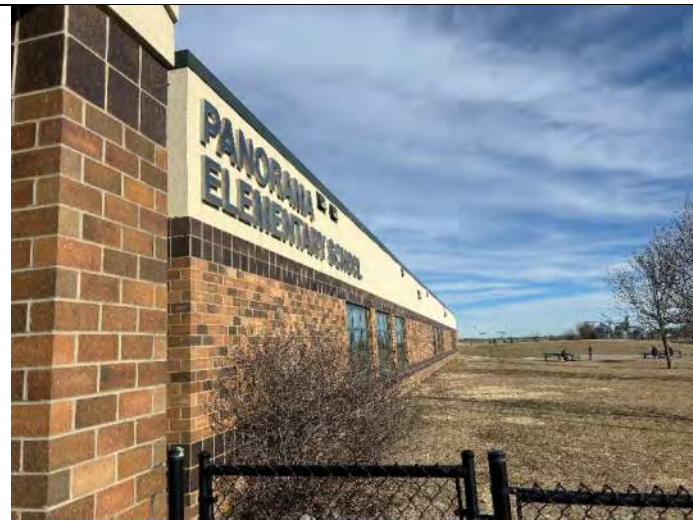
Elevation 1: EIFS needs repaired.

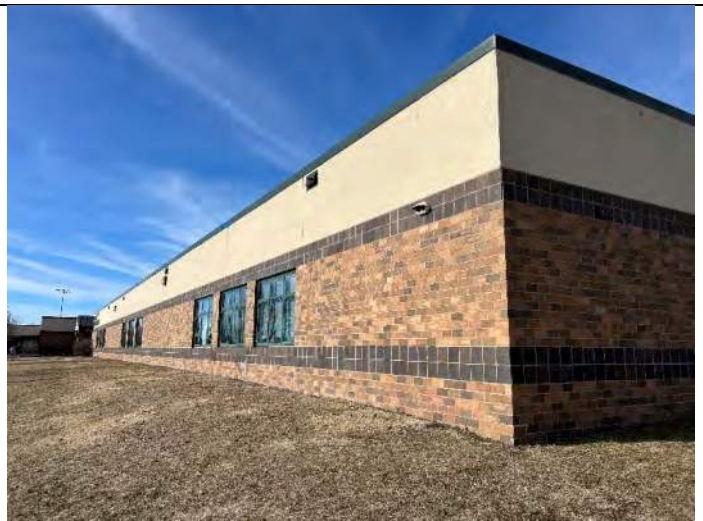
Elevation 1: Looks like woodpecker damage at east end.

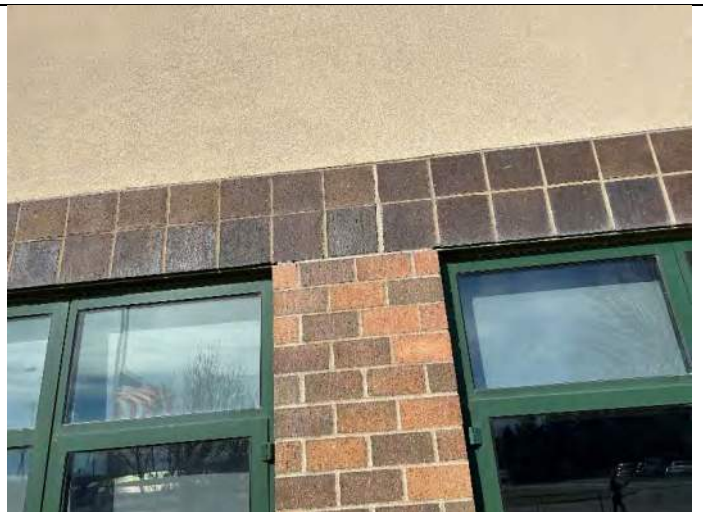
Elevation 1: Mortar failed between windows.

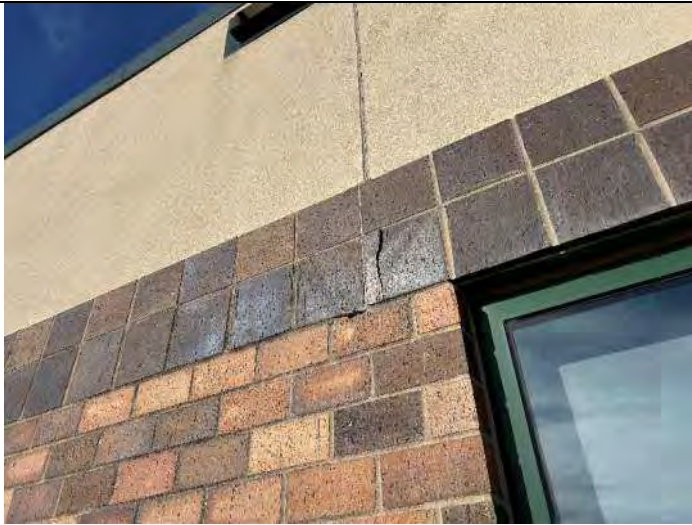
Elevation 1: Repair failed brick, seal control joint.

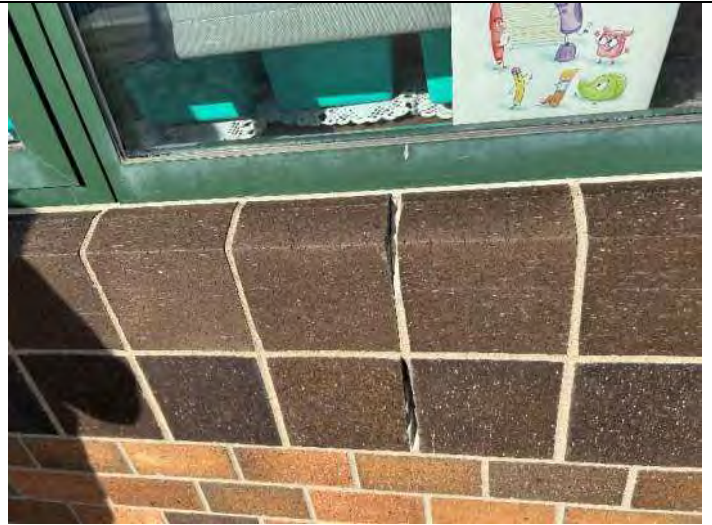
Elevation 1: Repair mortar, reseal windows.

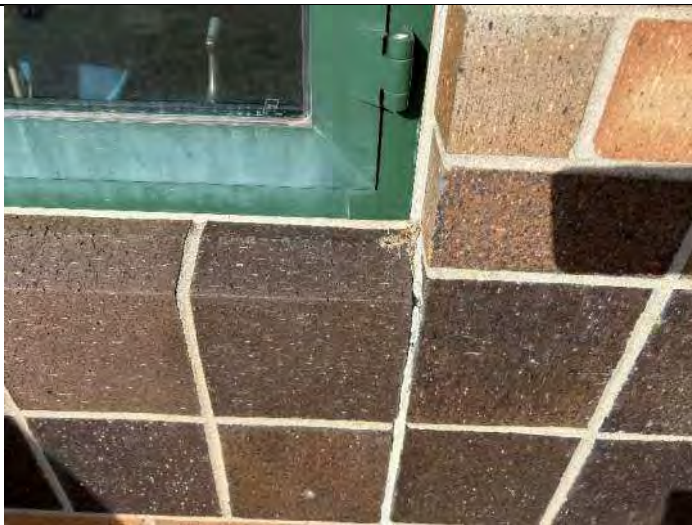
Elevation 1: Control joint needs mortar removed and sealant installed.

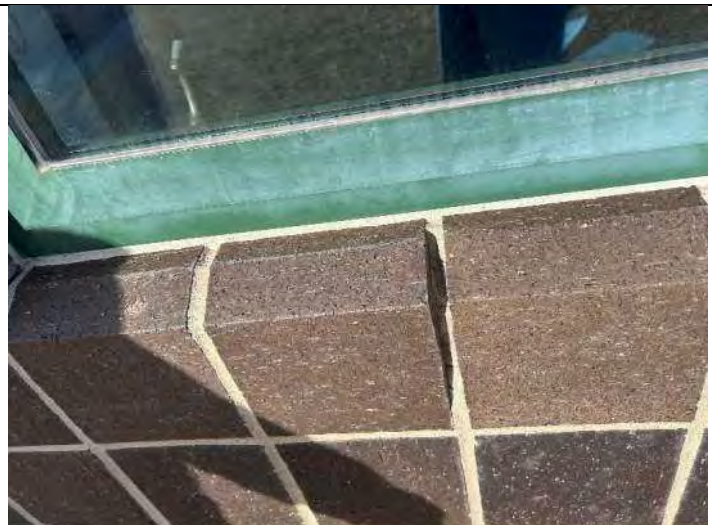
Elevation 3: Repair mortar, reseal windows.

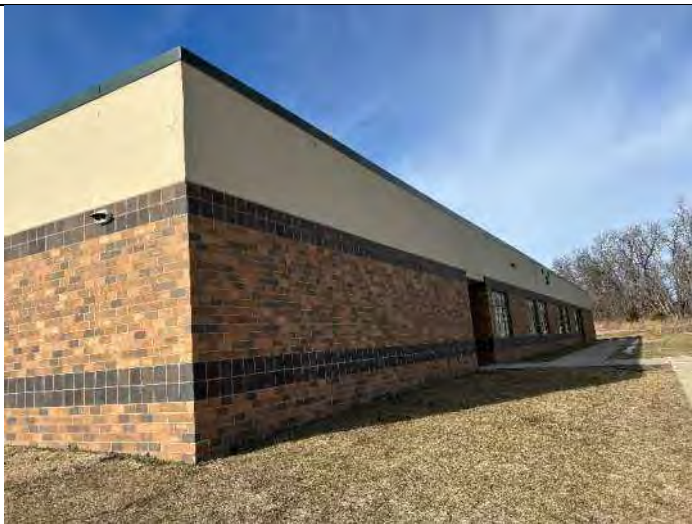
Elevation 2: Need EIFS repair and cleaning

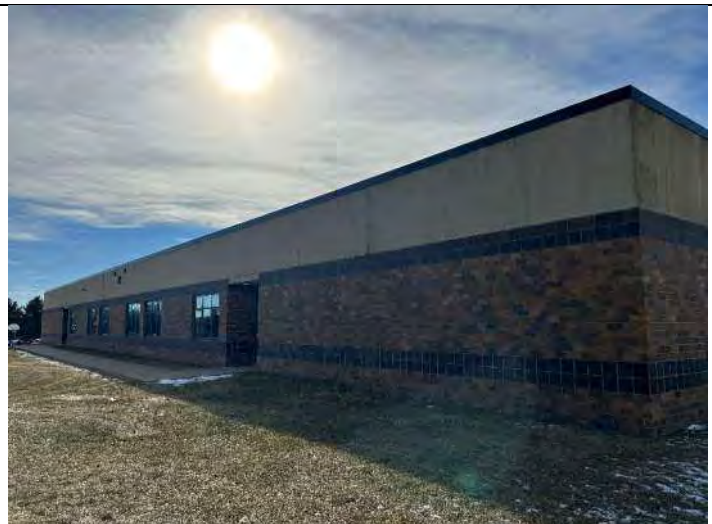
Elevation 2: EIFS needs repaired.

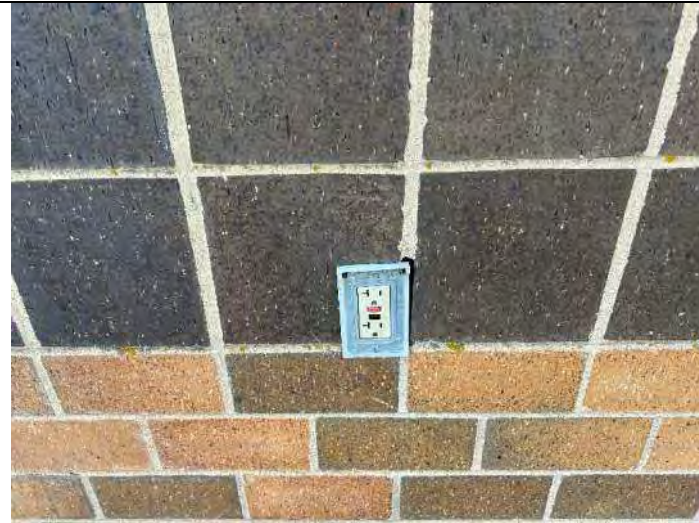
Elevation 2: Outlet needs cover and grout repair.

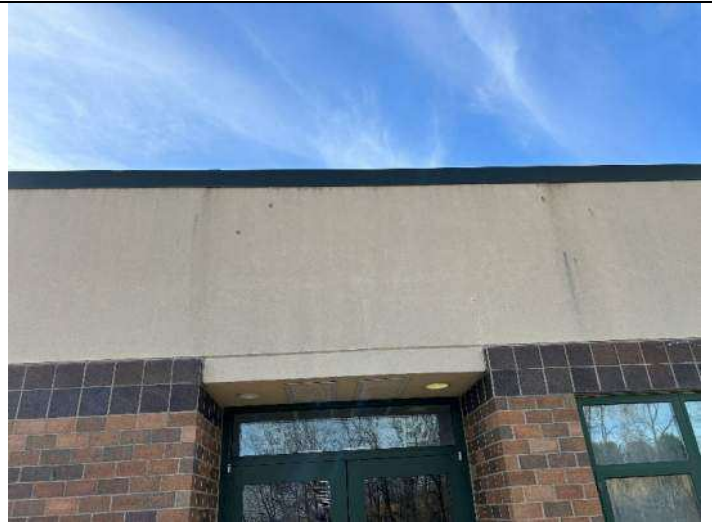
Elevation 2: Algae and woodpecker damage.

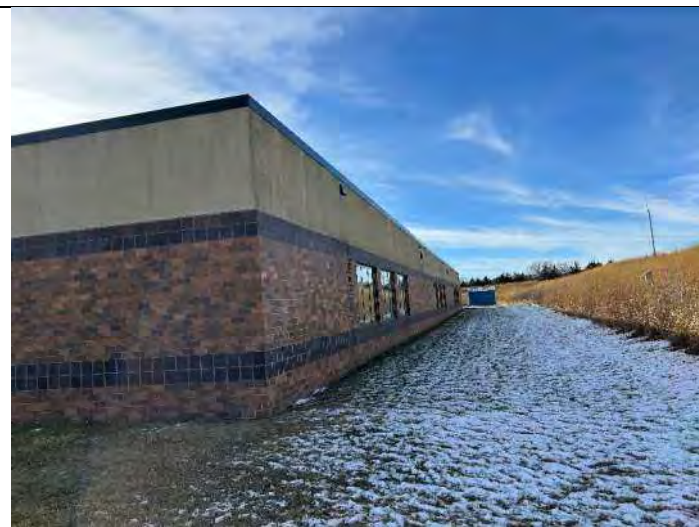
Elevation 3: Repair thin EIFS, reseal control joints.

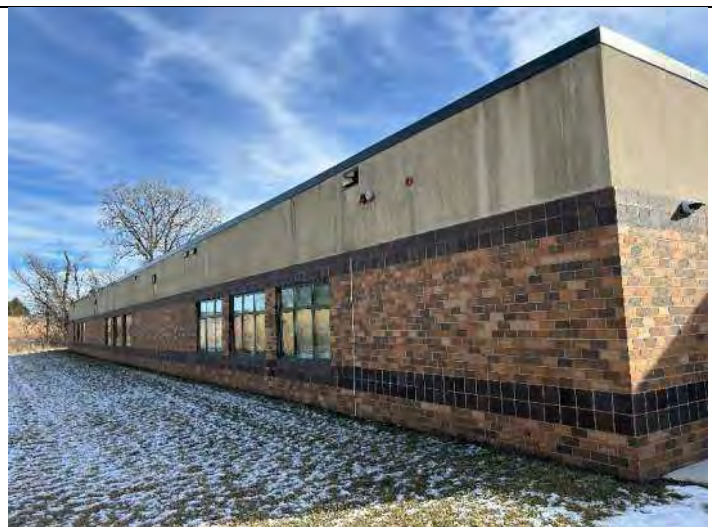
Elevation 3: Repair thin EIFS, reseal control joints.

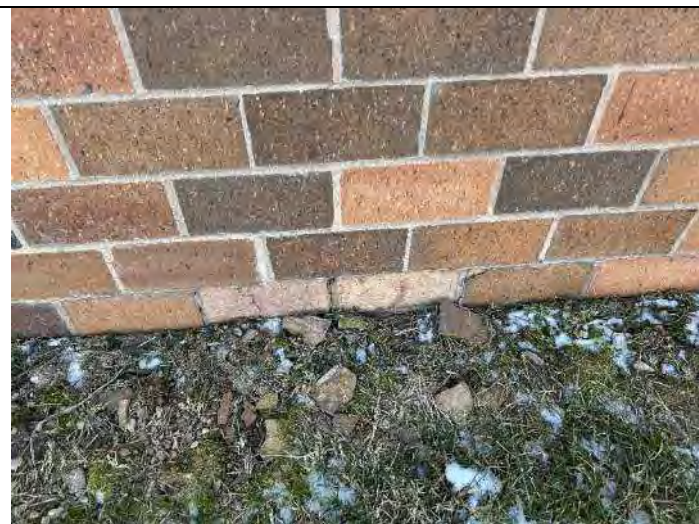
Elevation 3: Repair brick with spalling faces.

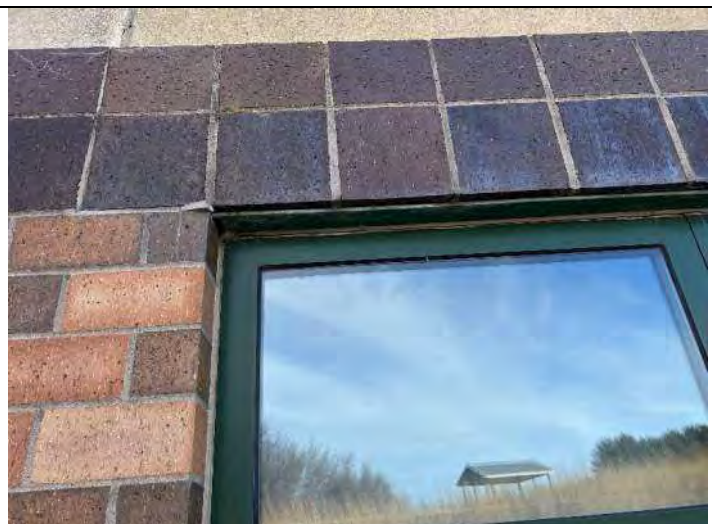
Elevation 3: Repair mortar at window head.

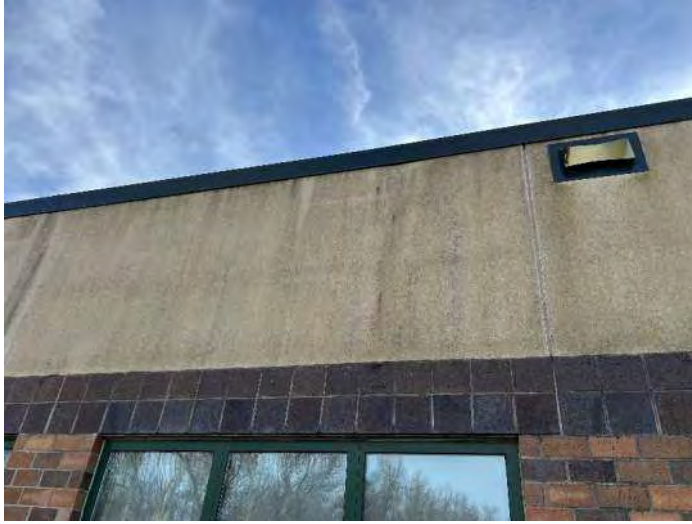
Elevation 3: Repair thin EIFS, reseal control joints.

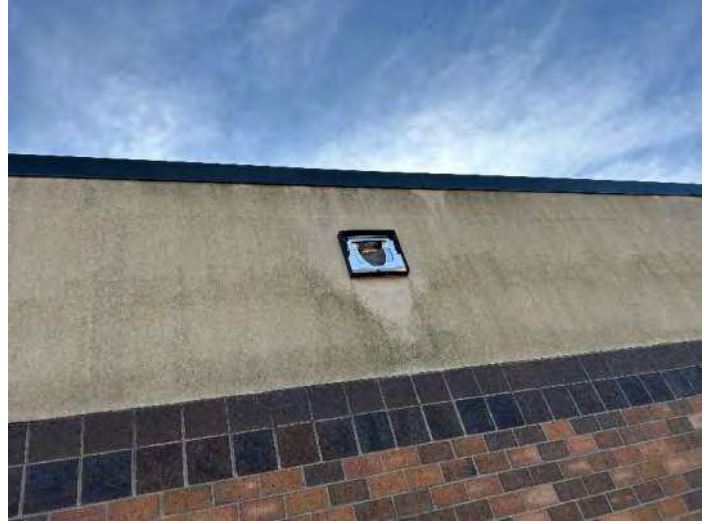
Elevation 3: Replace missing lense and bulb.

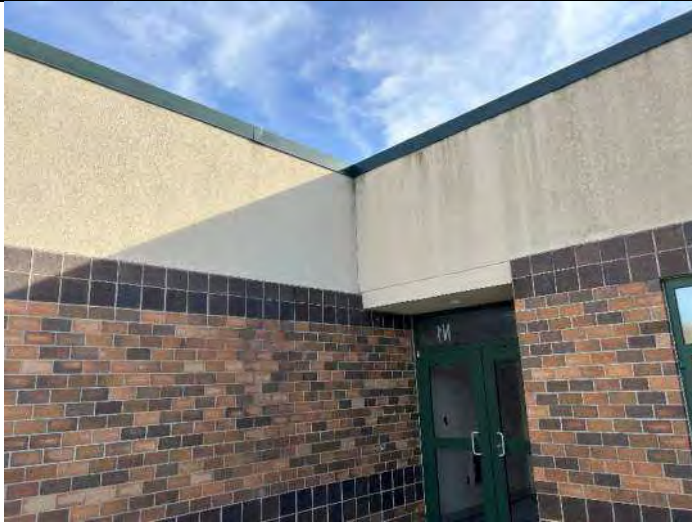
Elevation 4: Repair thin EIFS, reseal control joints.

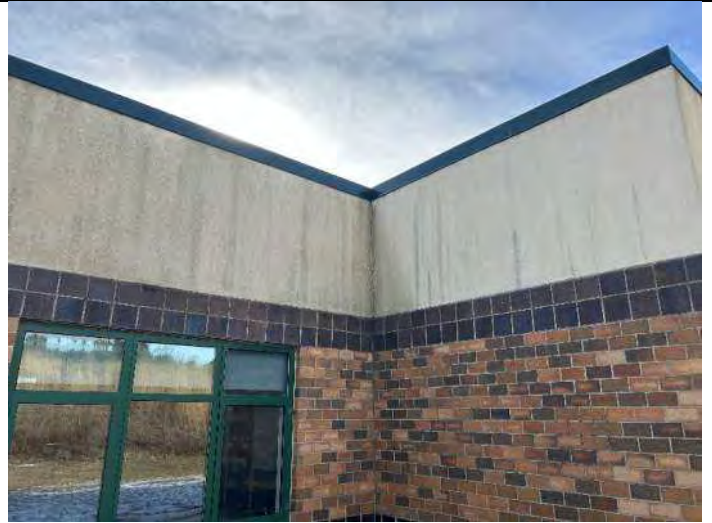
Elevation 4: Repair thin EIFS, reseal control joints.

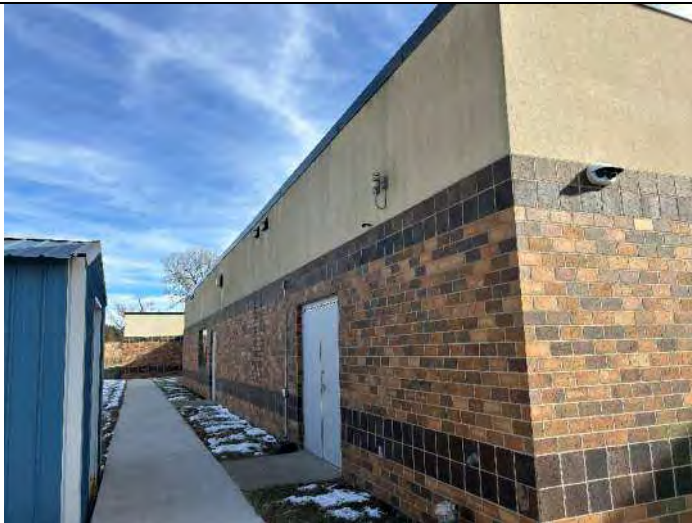
Elevation 5: Repair thin EIFS seal wall penetrations.

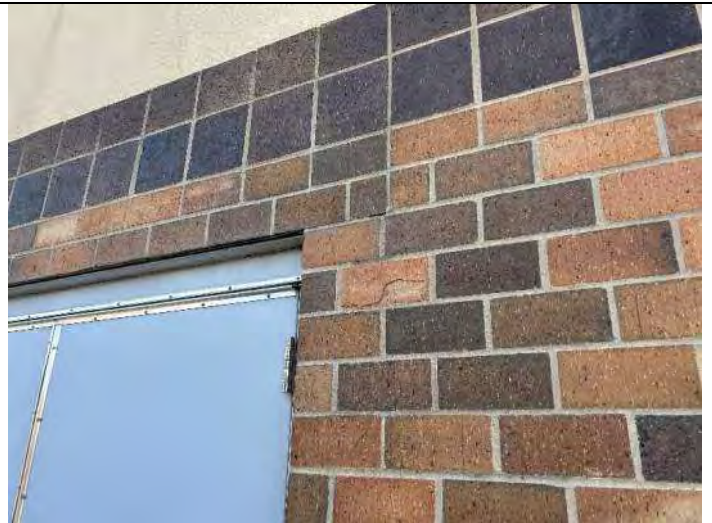
Elevation 5: Repair brick with broken face.

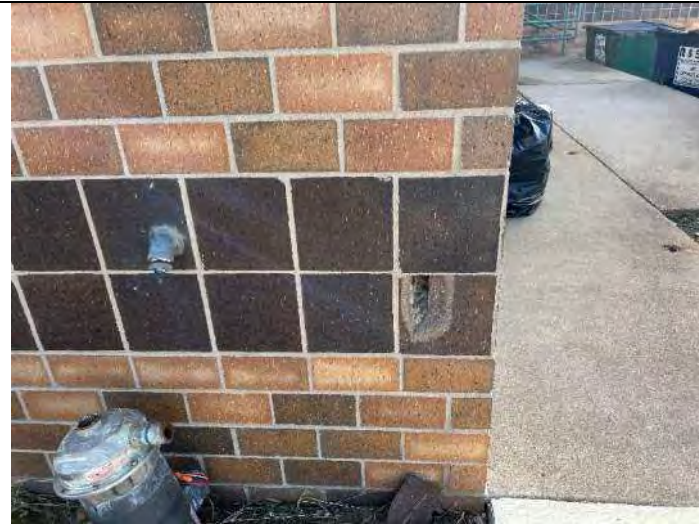
Elevation 5: Repair brick with broken face.

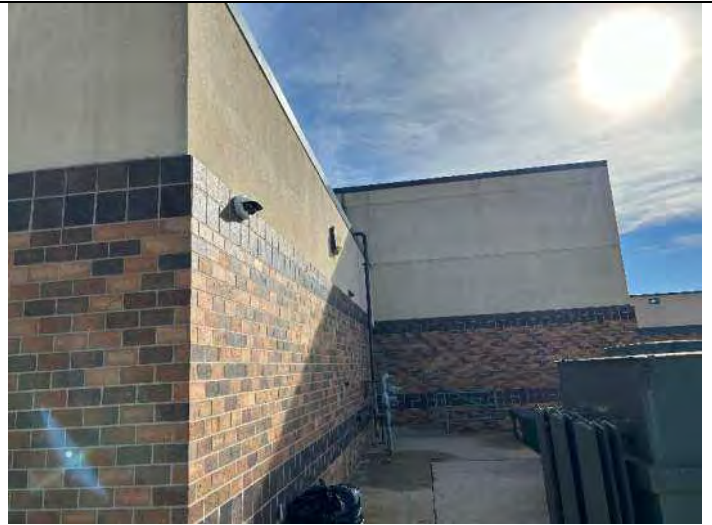
Elevation 6: Repair EIFS, paint gas pipe and railing.

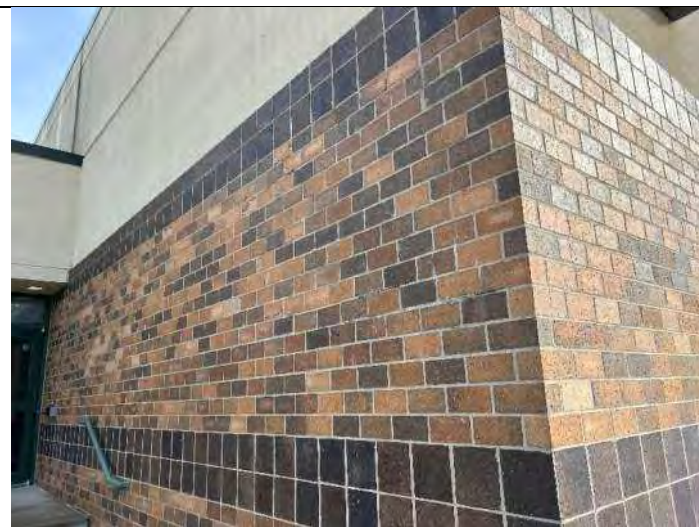
Elevation 6: Repair spalling brick faces.

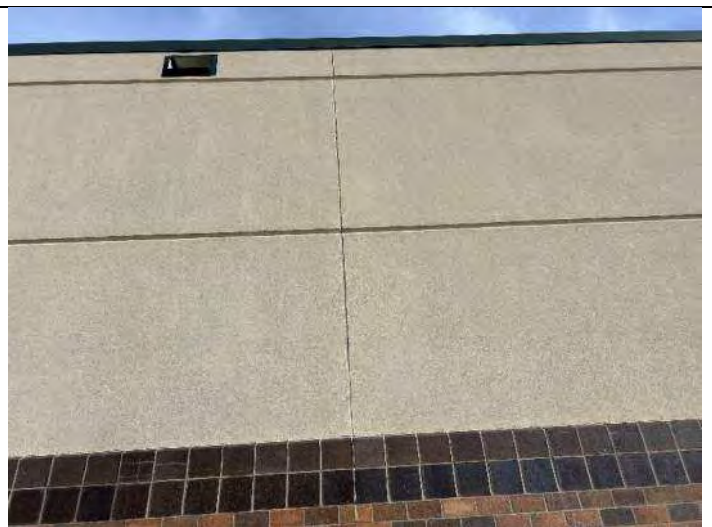
Elevation 6: Reseal control joints.

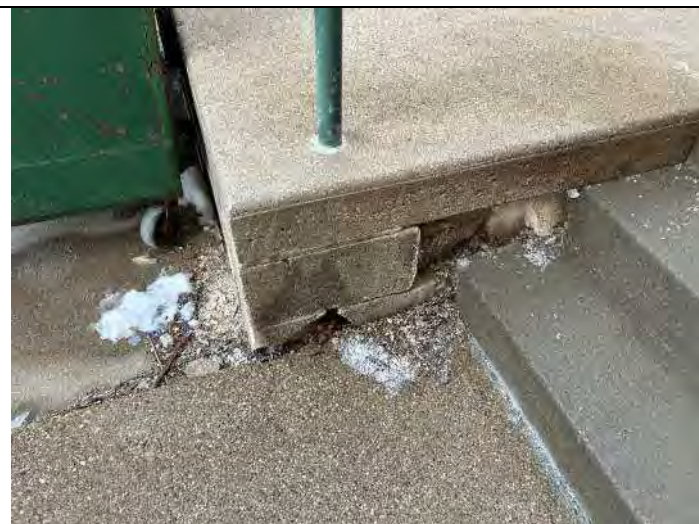
Elevation 6: Repair CMU loading dock.

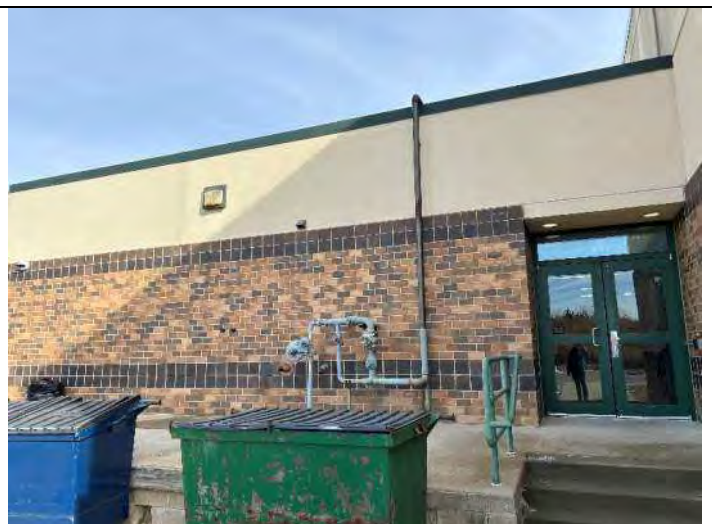
Elevation 6: Repair EIFS, paint gas pipe and railing.
