**Building and Facility Assessment
Panorama Community School District
High School / Middle School
701 W Main St, Panora, IA 50216**

February 27, 2025

Project: #25003 Panorama CSD Envelope Review

Purpose: Assessment Review of Elementary & High School / Middle School Envelopes and Systems

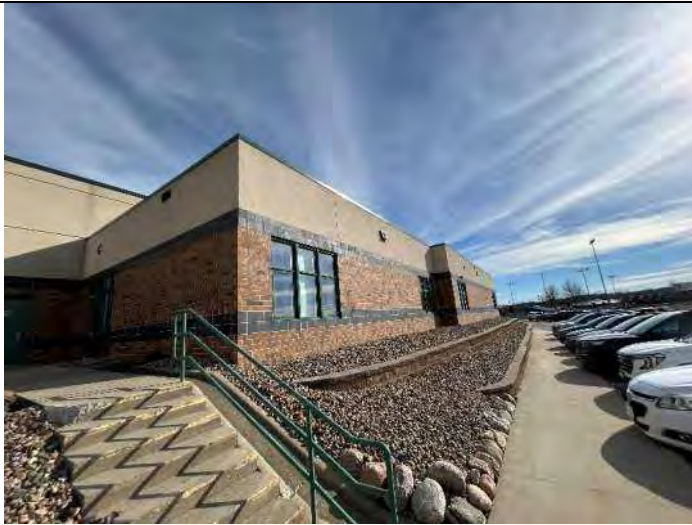
Elevation 7: Reseal control joints.

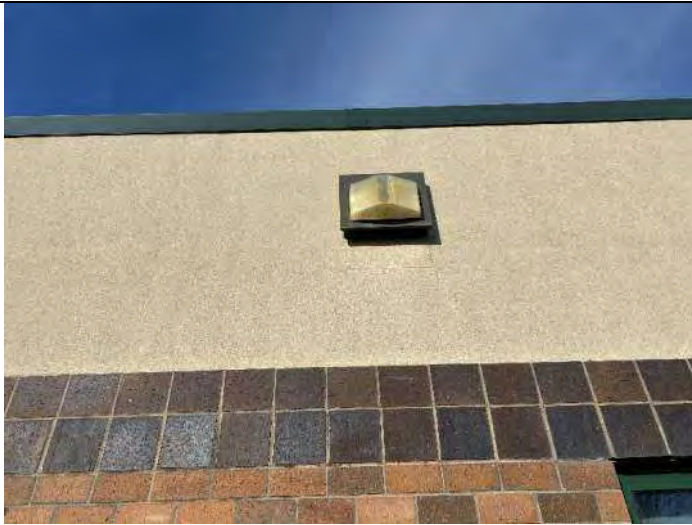
Elevation 10: EIFS repair needed below light.

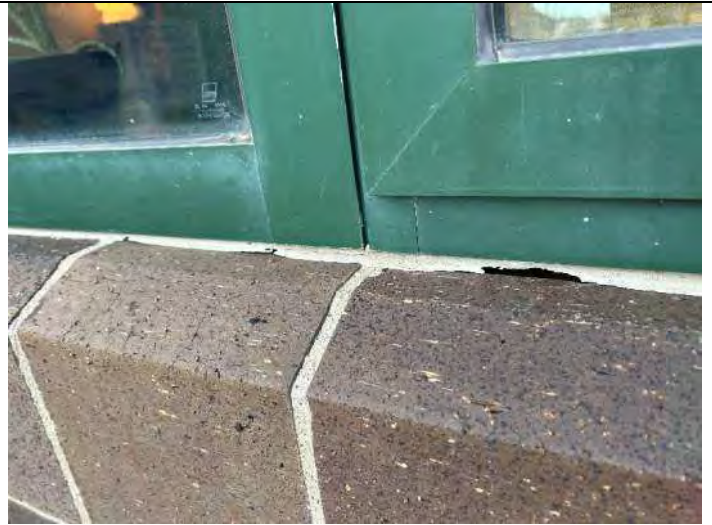
Elevation 10: Windows need resealed.

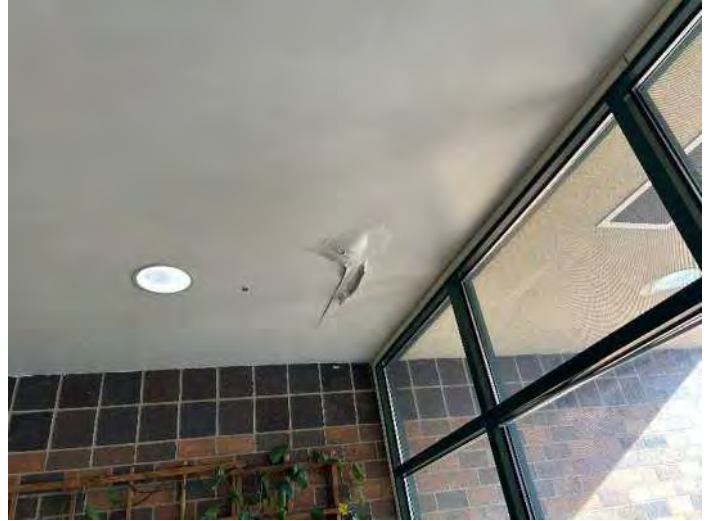
Elevation 11: Leak below roof transition above.

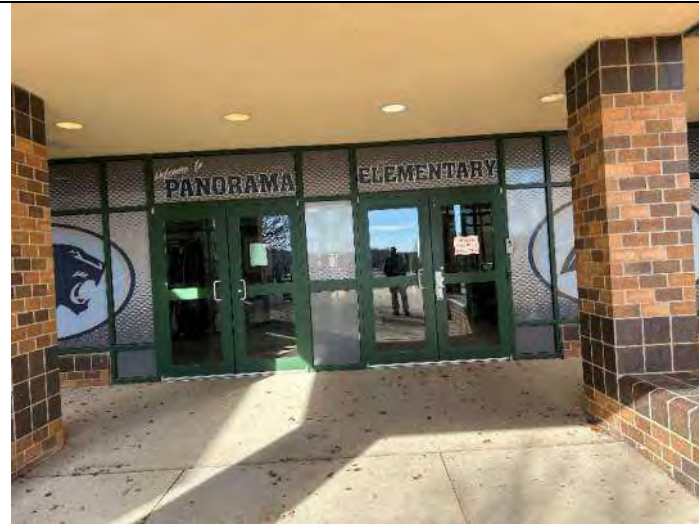
Elevation 11: No issues.

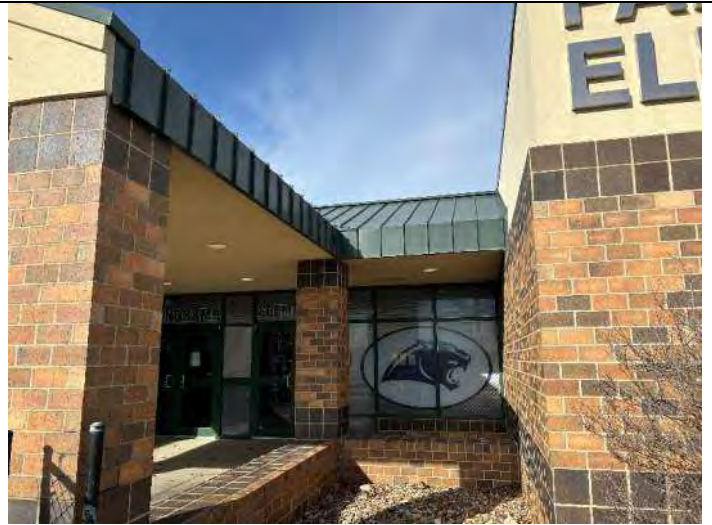
Elevation 11: Leak at ceiling behind panther.

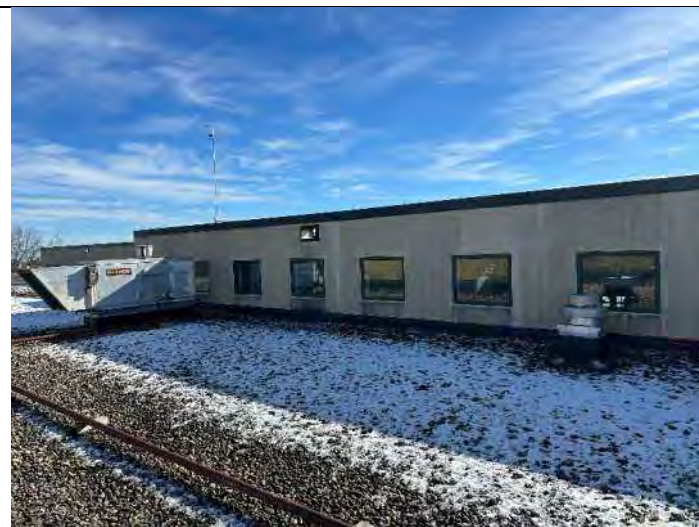
Elevation 12: EIFS is thin and needs cleaning.
