**Building and Facility Assessment
Panorama Community School District
High School / Middle School
701 W Main St, Panora, IA 50216**

February 27, 2025

Project: #25003 Panorama CSD Envelope Review

Purpose: Assessment Review of Elementary & High School / Middle School Envelopes and Systems

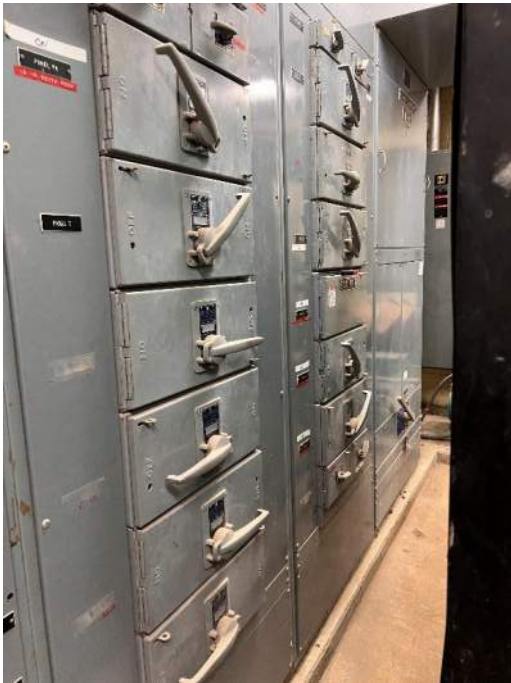
Figure 1 – Main Electrical Switchboard showing Boiler Encroachment at right

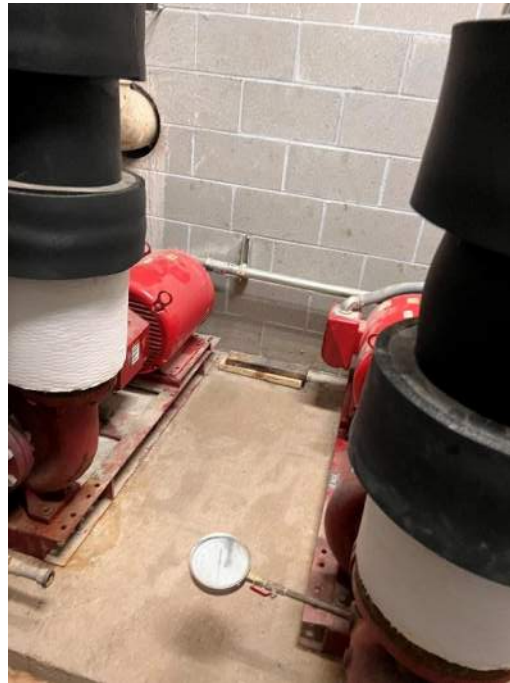
Figure 2- 2007 Addition Geo Pumps

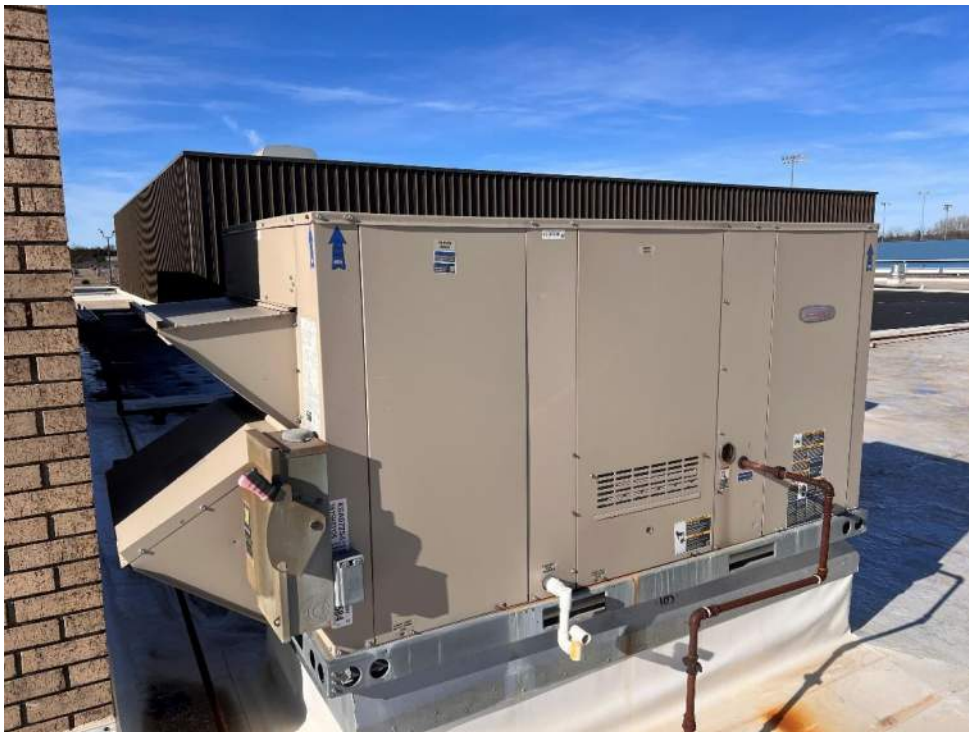
Figure 3 – Roof Top HVAC Unit on Roof

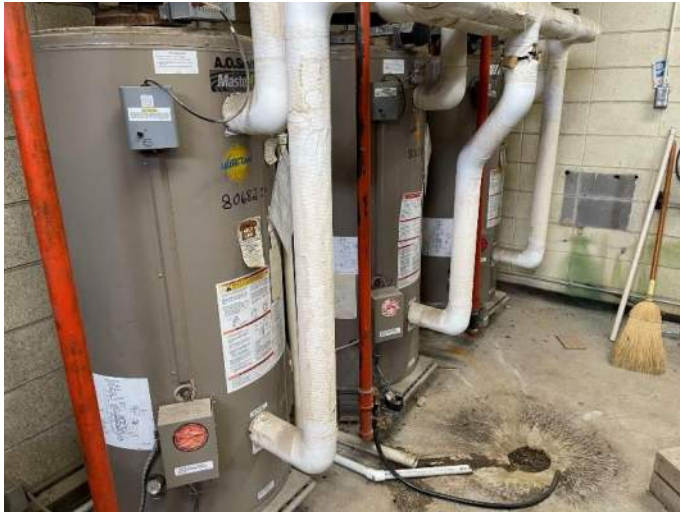
Figure 4- Domestic Water Heaters

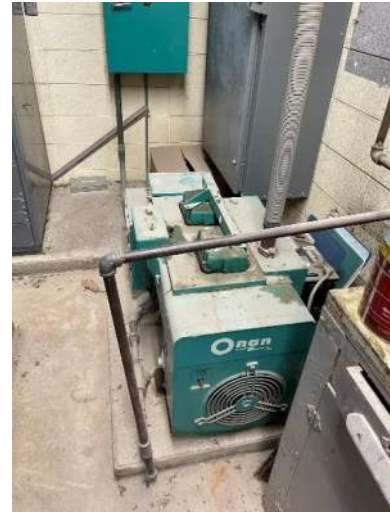
Figure 5- Existing Onan Emergency Generator

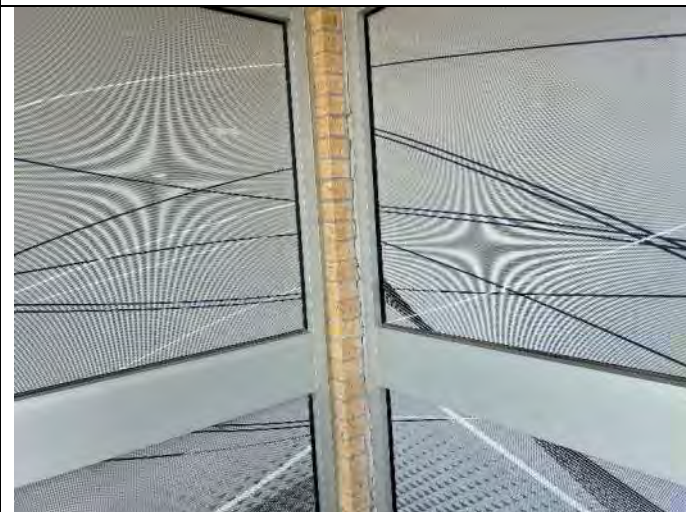
Elevation 1: Grout between frame and brick.

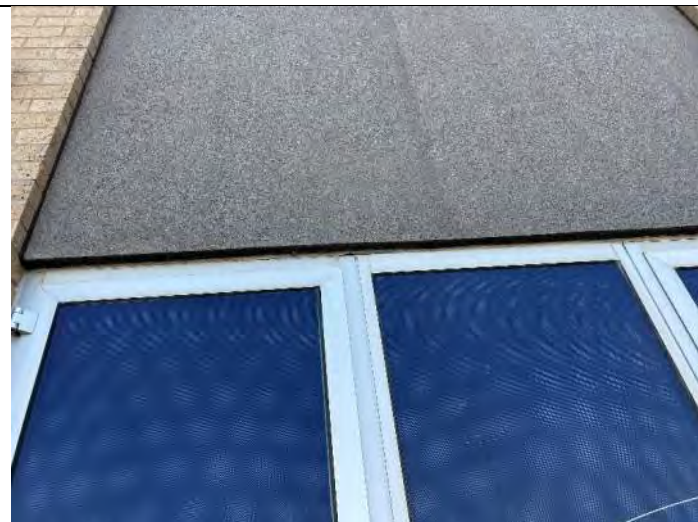
Elevation 3: New sealant required around windows and EIFS

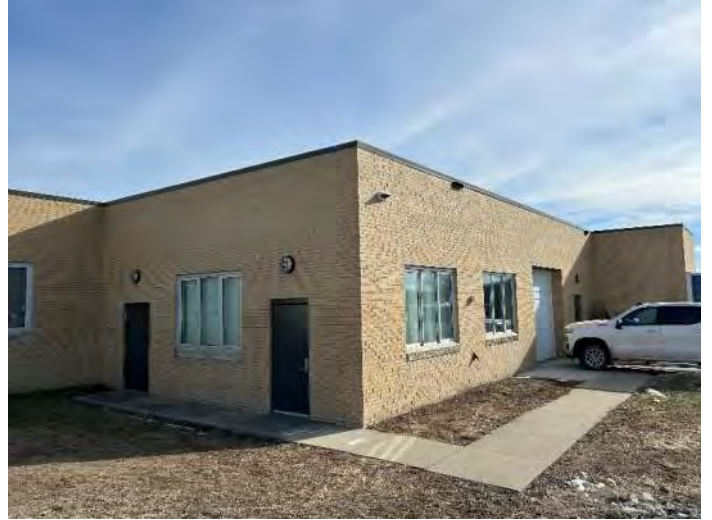
Elevation 4: Clean algae from sills.

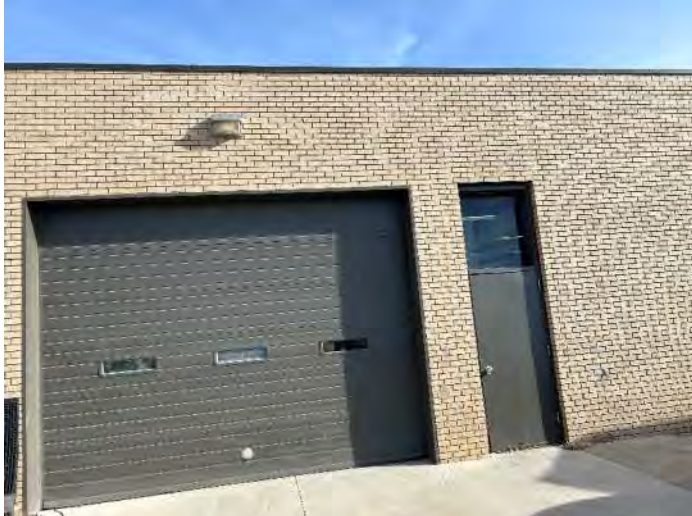
Elevation 5: Replace HM door.

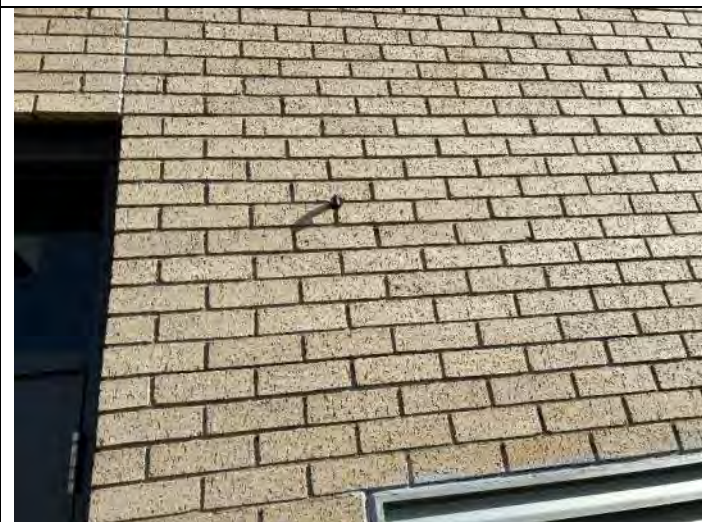
Elevation 6: New sealant at louver and drain.

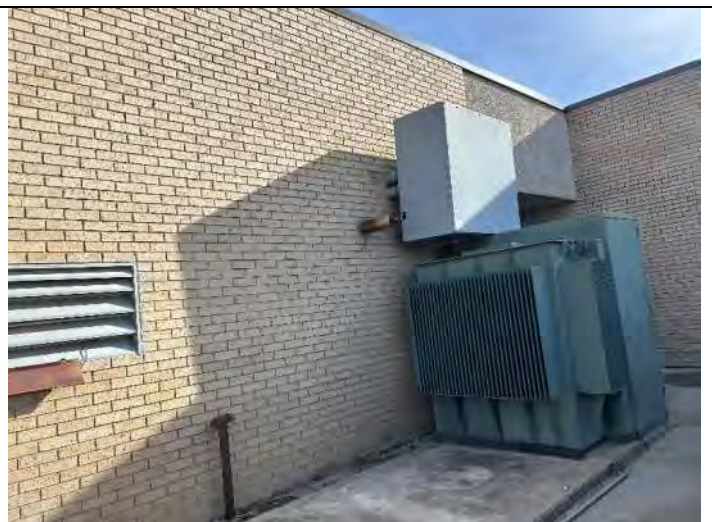
Elevation 6: Remove unneeded equipment.

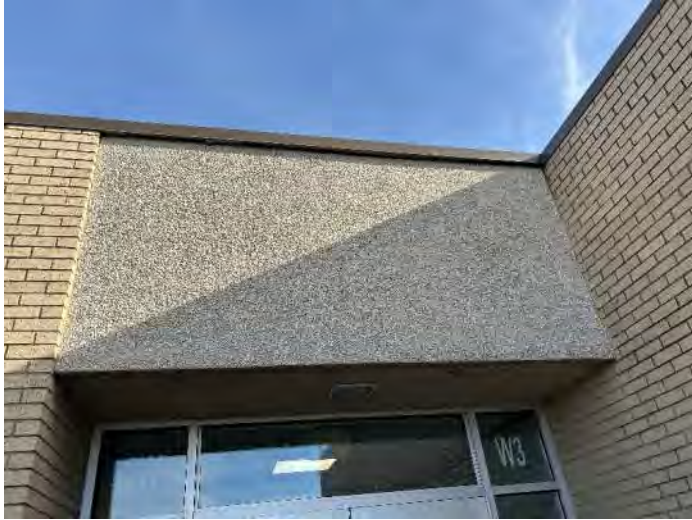
Elevation 6: Finish exposed wood under coping.

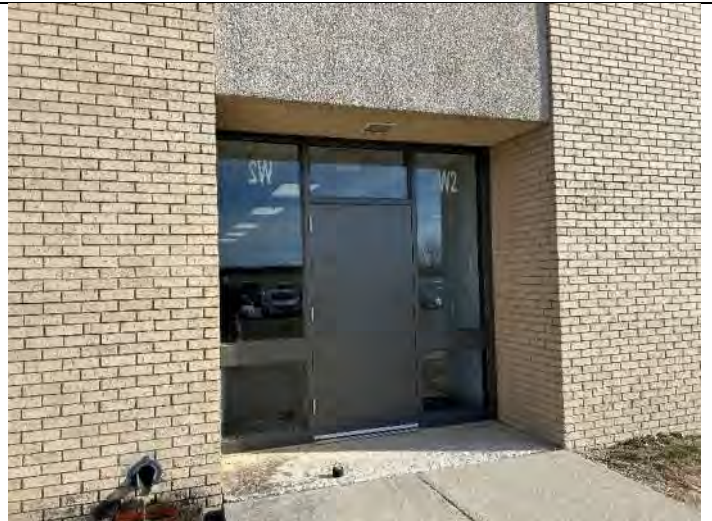
Elevation 7: Reseal stone panel and door frame.

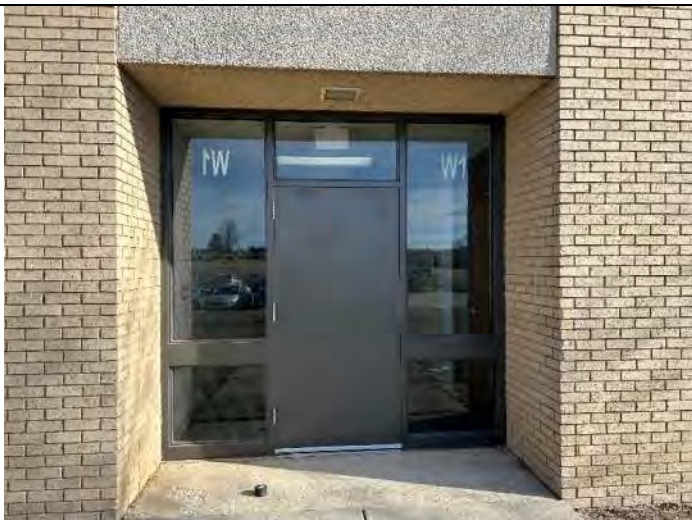
Elevation 7: Reseal stone panel and door frame.

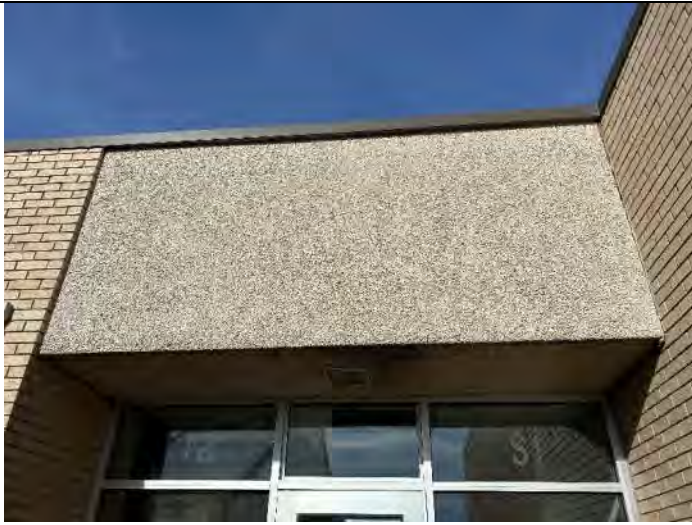
- h. In the original building, exposed aggregate precast panels were used at the entries and windows. These panels are only about 1" thick and in at least one location the horizontal panel is sagging. It may be possible to repair the supporting structure and take the bend out of the panel. If this isn't possible the panels above the doors and windows can be replaced with EIFS.

Elevation 7: Reseal stone panel and door frame. Resupport sagging framing of stone panel.

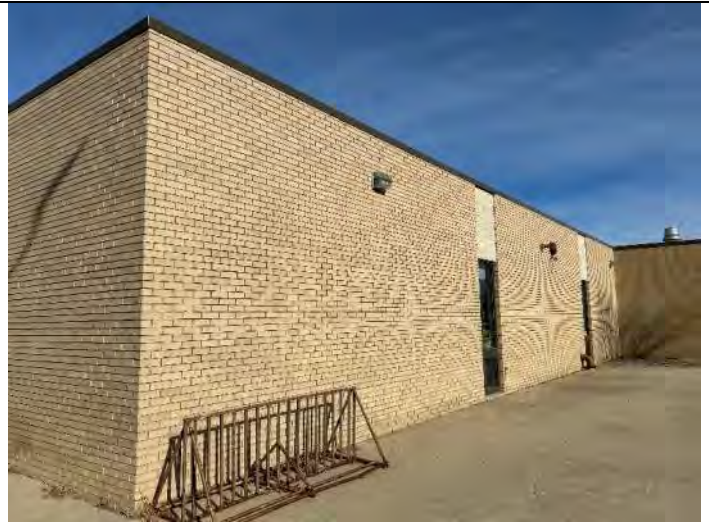
Elevation 8: Reseal window frame, finish exposed wood.

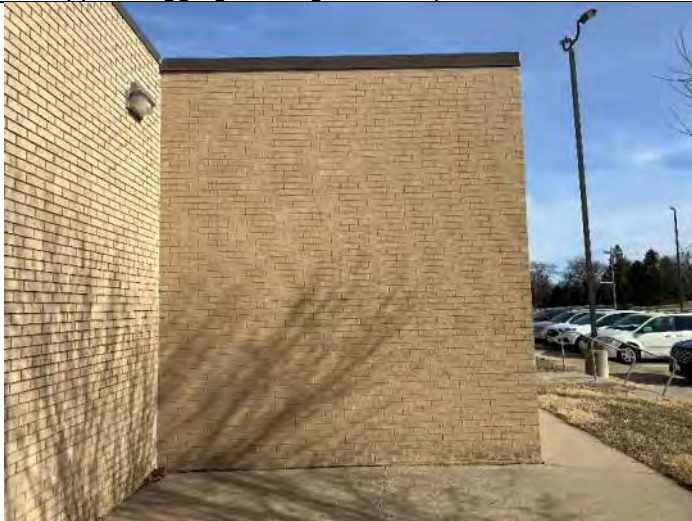
Elevation 9: Check slope of slab.

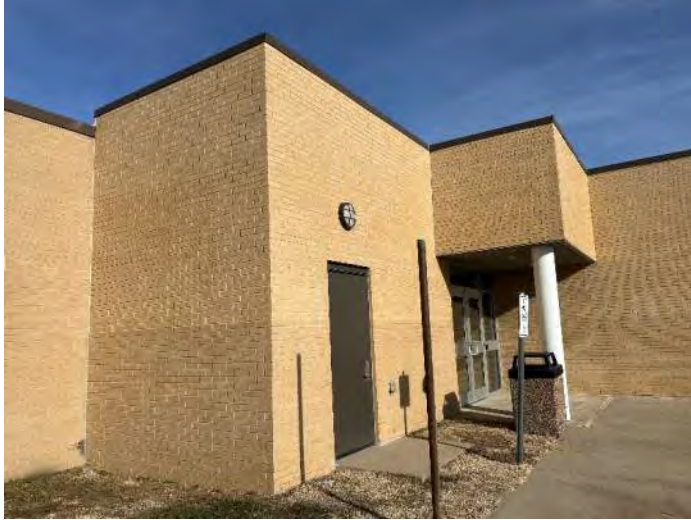
Elevation 10: Sealant at control joints is failed.

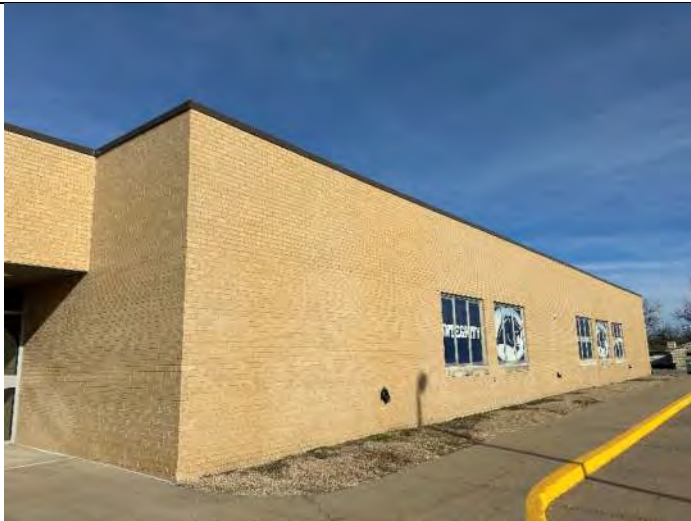
Elevation 10: Windows needs new sealant and sills cleaned .

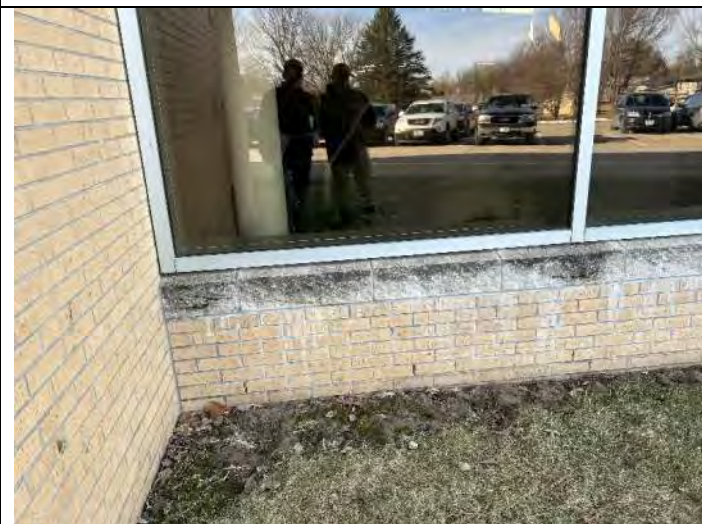
Elevation 12: Clean and seal brick and sill.

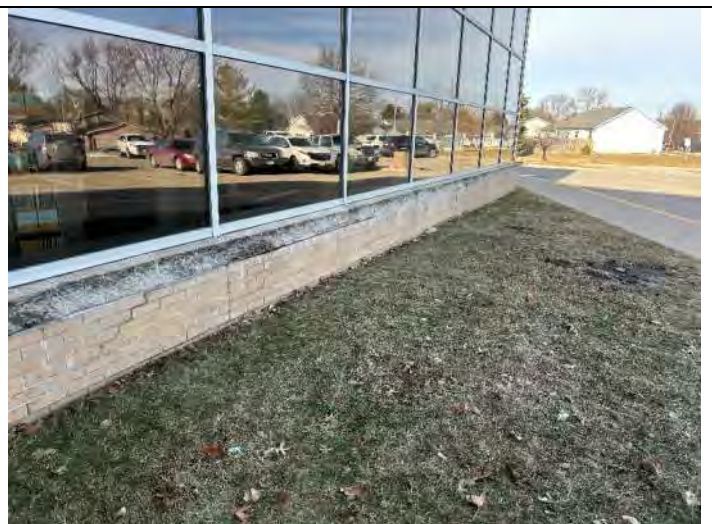
Elevation 12: Clean and seal brick and sill.

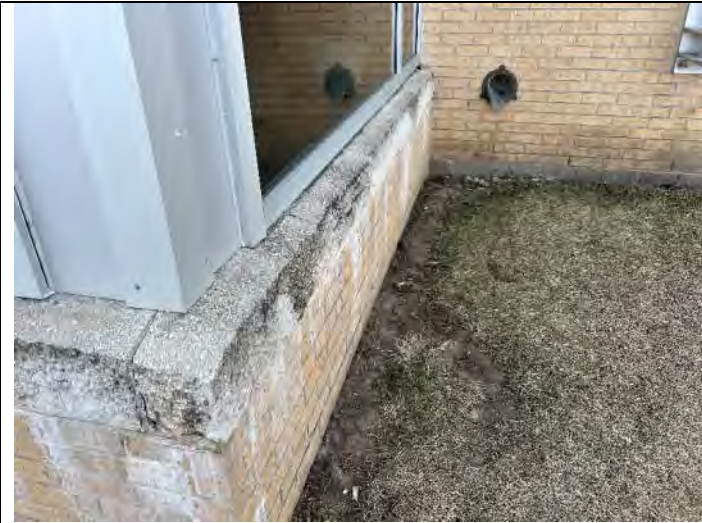
Elevation 12: Clean and seal brick and sill.

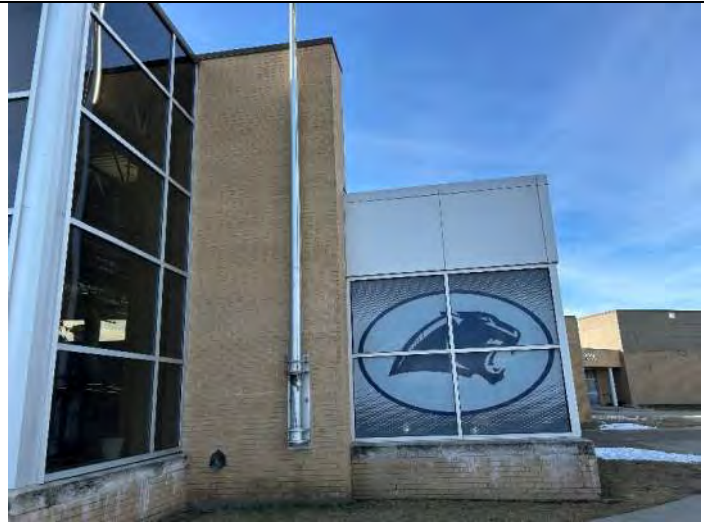
Elevation 12: Clean and seal brick and sill.

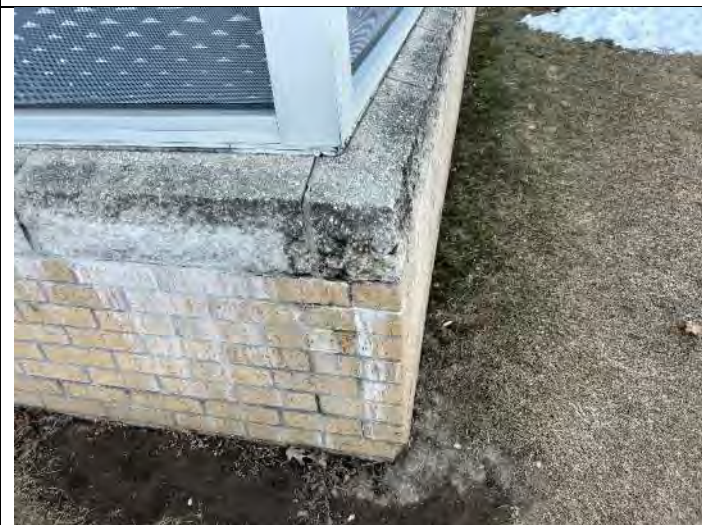
Elevation 12: Clean and seal brick and sill.

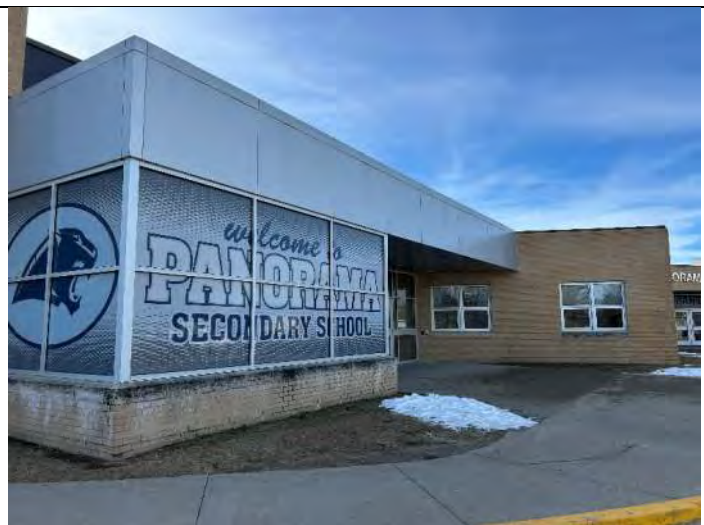
Elevation 12: Clean and seal brick and sill.

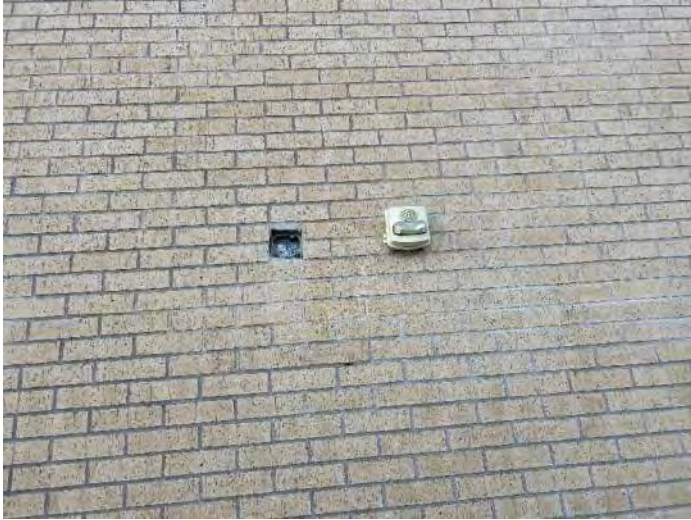
Elevation 12: Electrical box needs a cover.

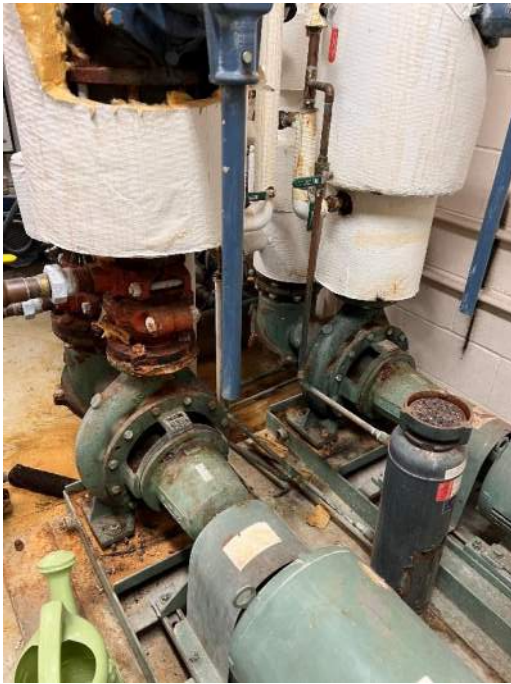
Figure 1 – Geothermal Loop Pumps

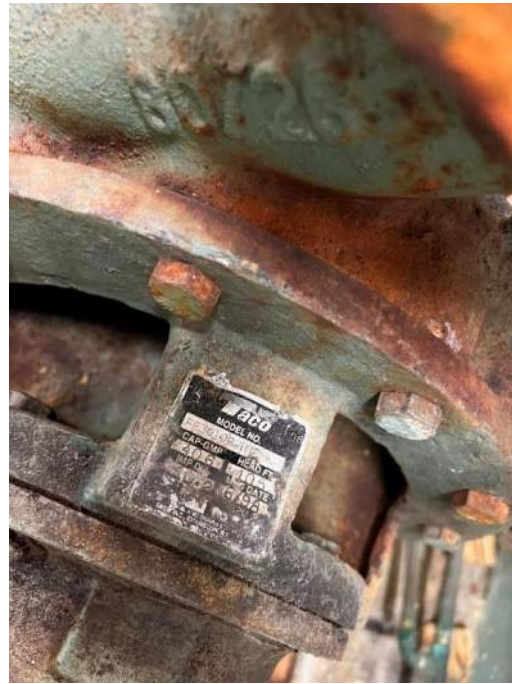
Figure 2- Close-up of Corrosion on Geo Pump

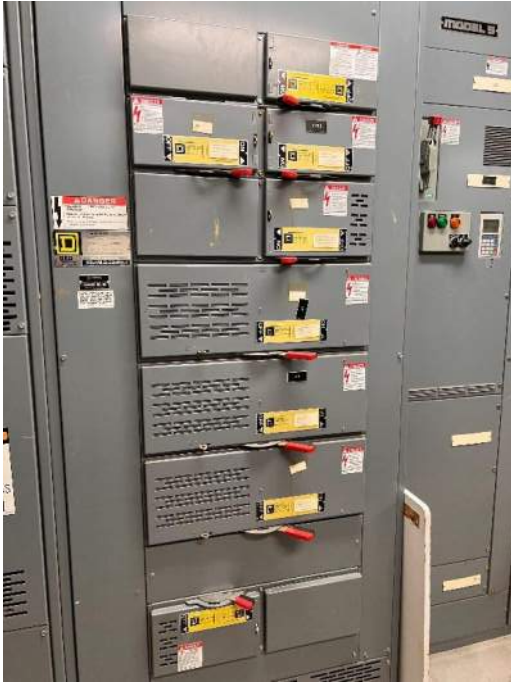
Figure 4- Main Electrical Service Gear

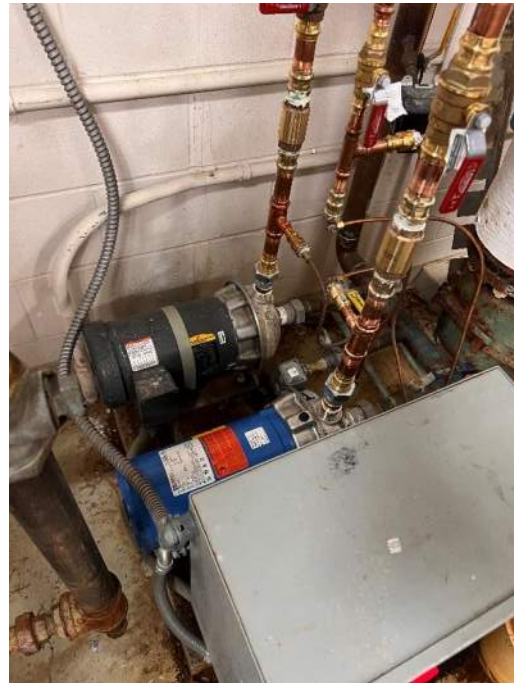
Figure 5- Domestic Water Booster Pumps

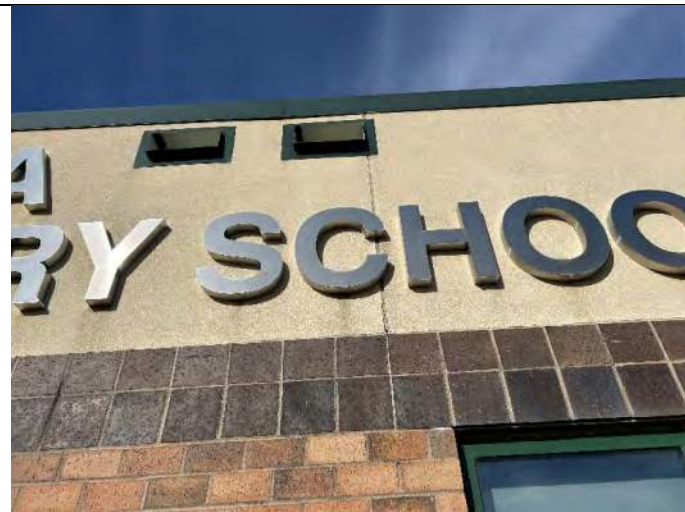
Elevation 1: Reseal control joints.

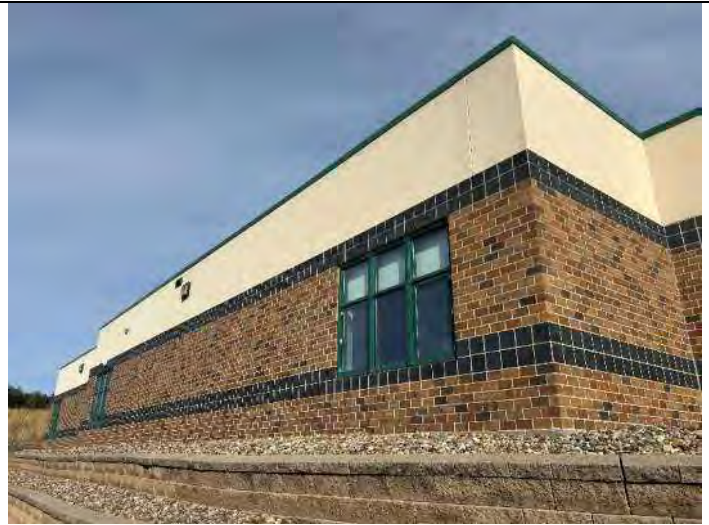
Elevation 7: Reseal control joints.

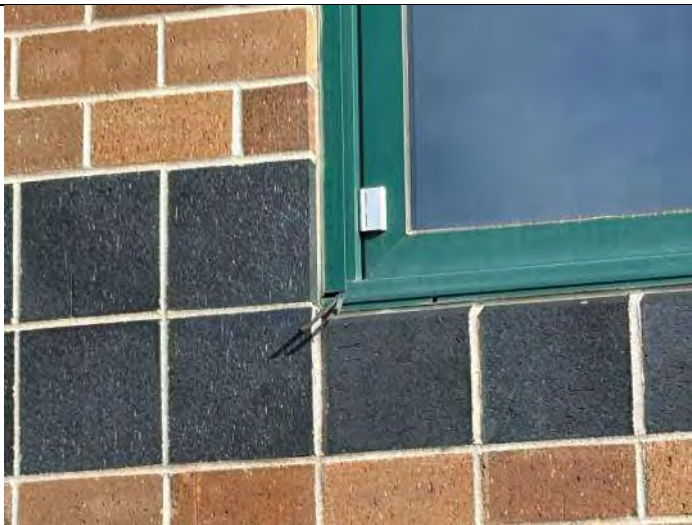
Elevation 7: Vinyl seals coming out of window.

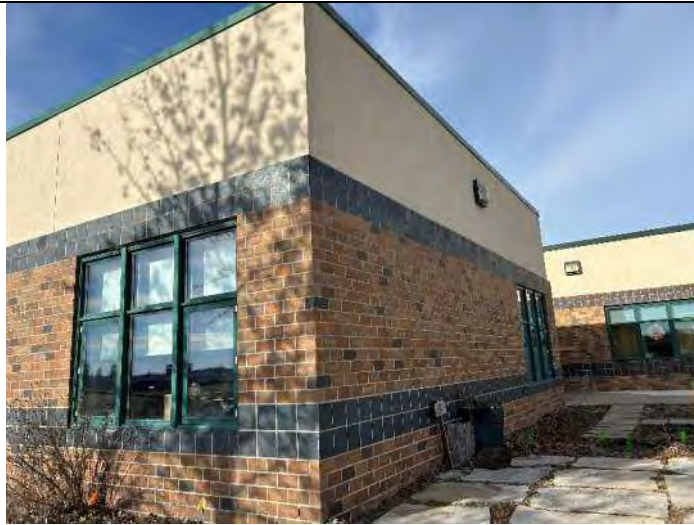
Elevation 7: EIFS is thin and needs cleaning.

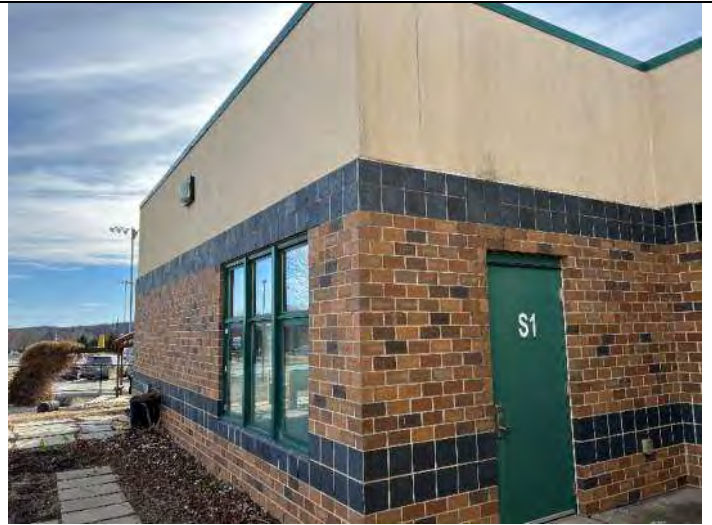
Elevation 8: Reseal windows and doors.

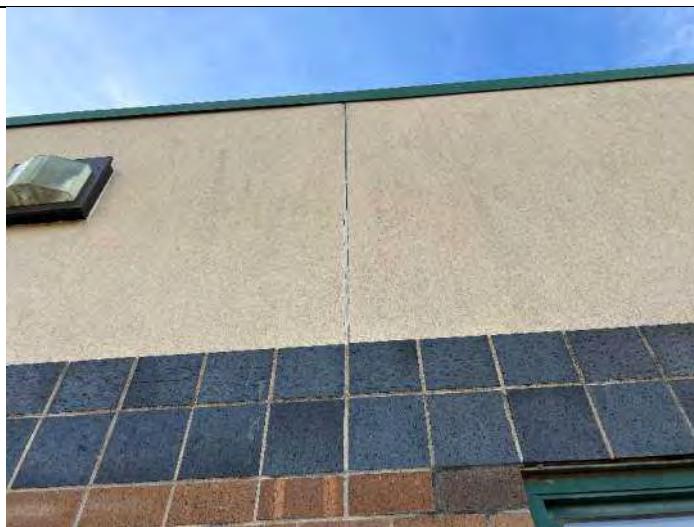
Elevation 9: Reseal control joints.

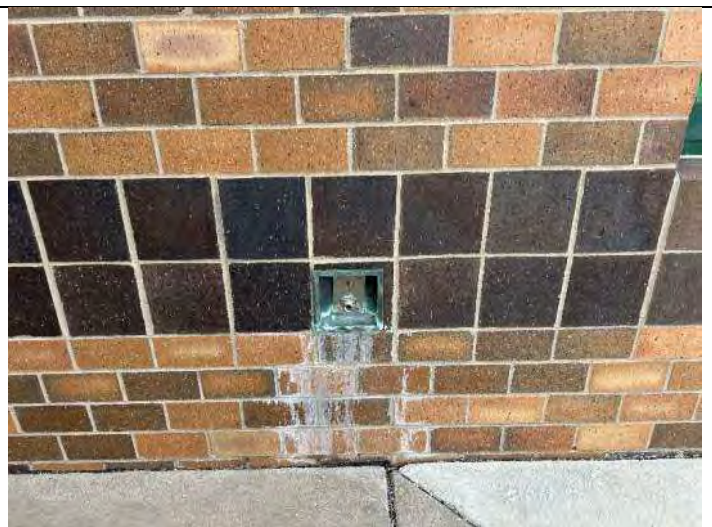
Elevation 9: Clean lime off brick.

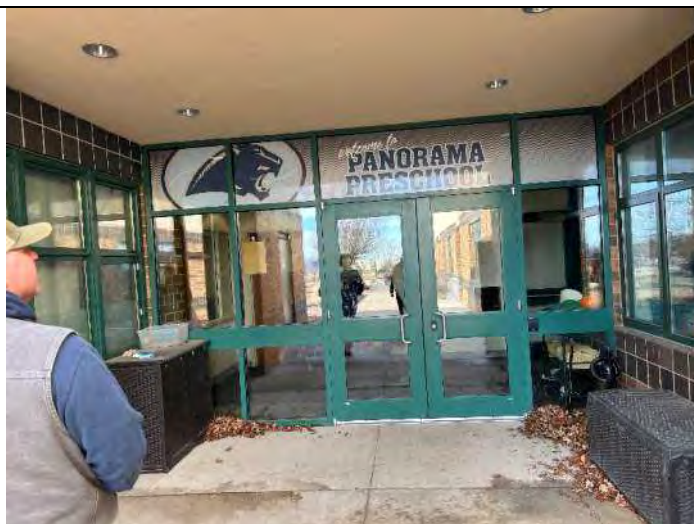
Elevation 9: Reseal windows all around.

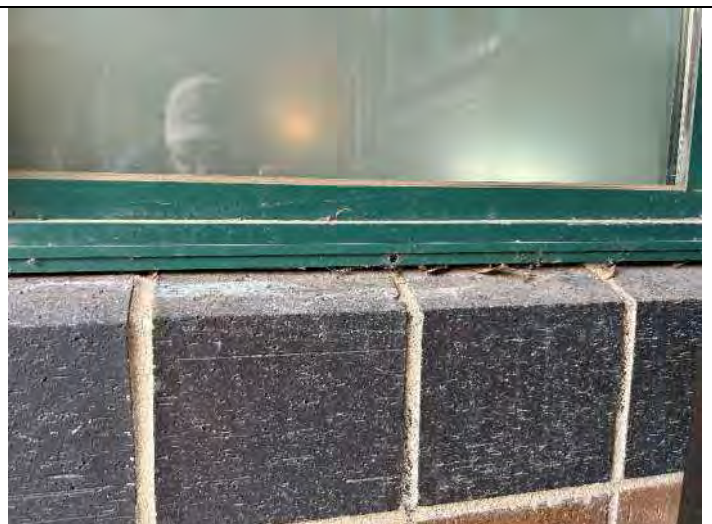
Elevation 9: No sealant below storefront window.

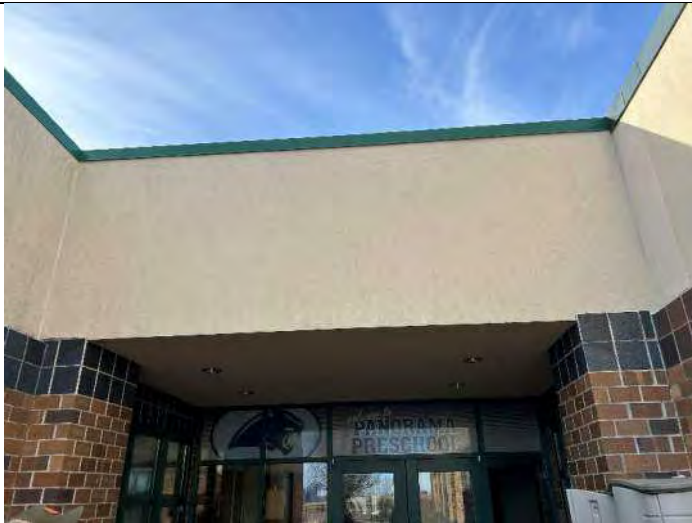
Elevation 10: Corner control joints need resealed.

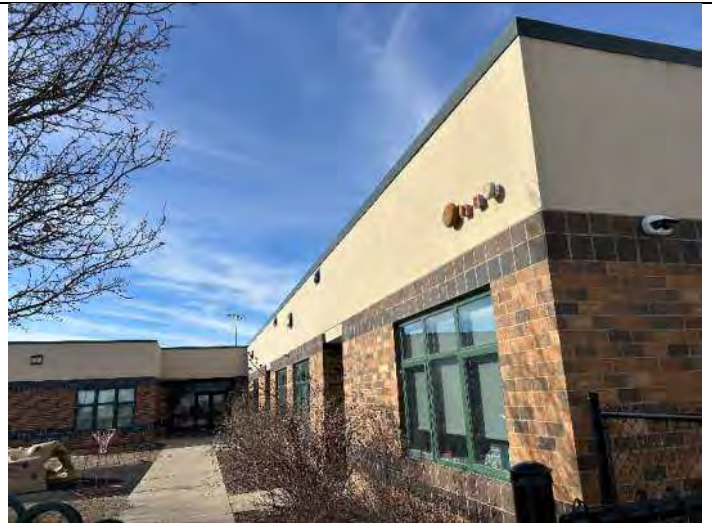
Elevation 10: EIFS is thin and needs cleaning.

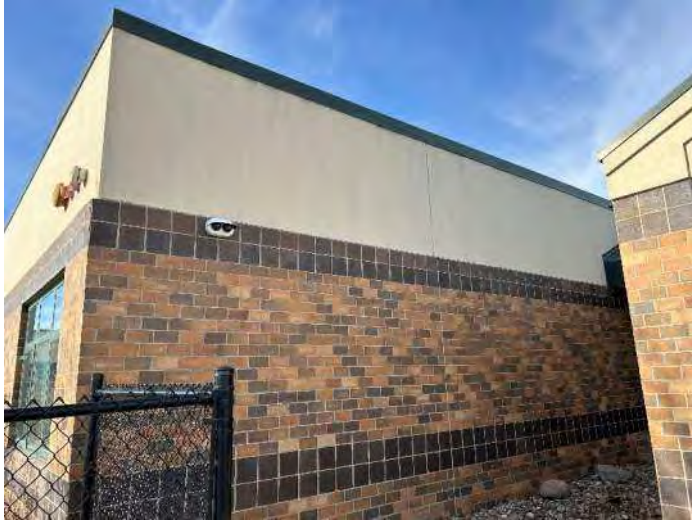
Elevation 11: EIFS is thin and needs cleaning.

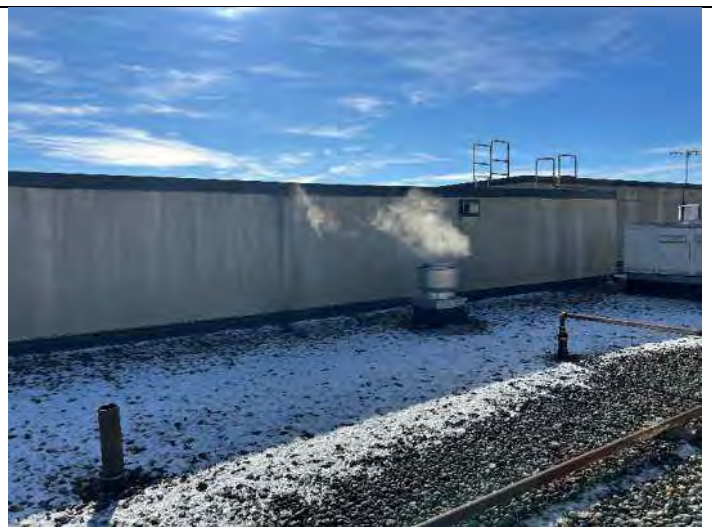
Elevation 12: EIFS is thin and needs cleaning.

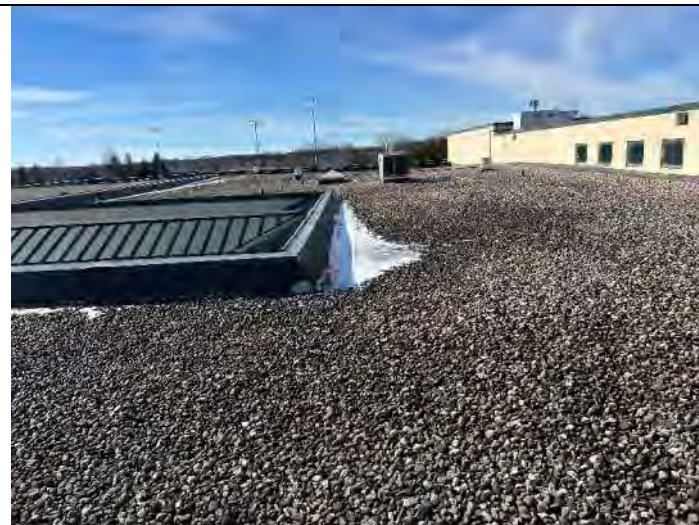
Elevation 12: EIFS is thin and needs cleaning.

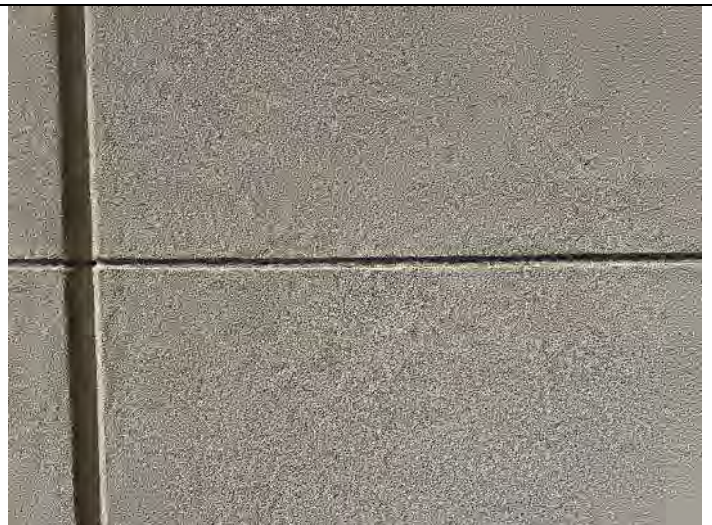
Elevation 12: Control joints need resealed.

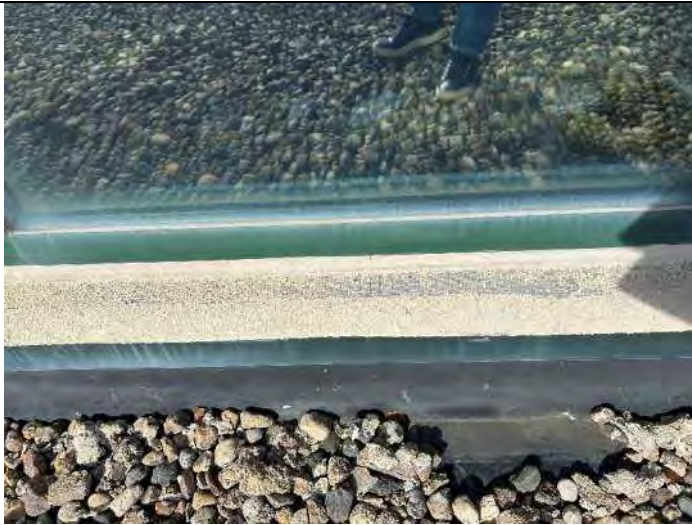
Elevation 12: EIFS sills are very thin.

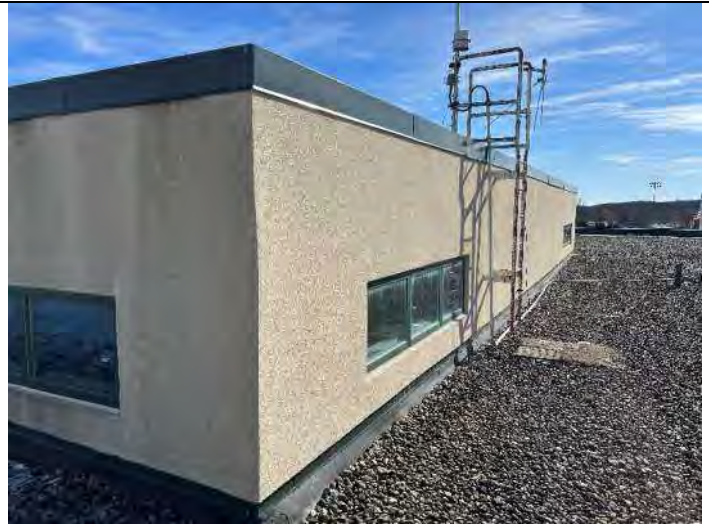
Elevation 13: EIFS is thin and needs cleaning.

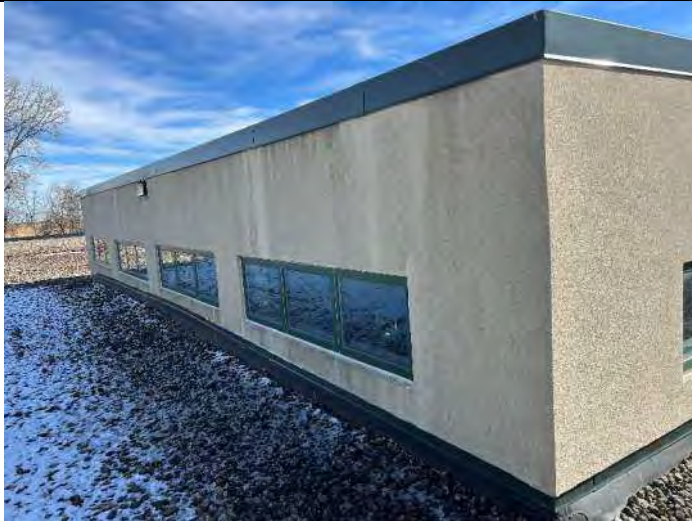
Elevation 13: EIFS is thin and needs cleaning.

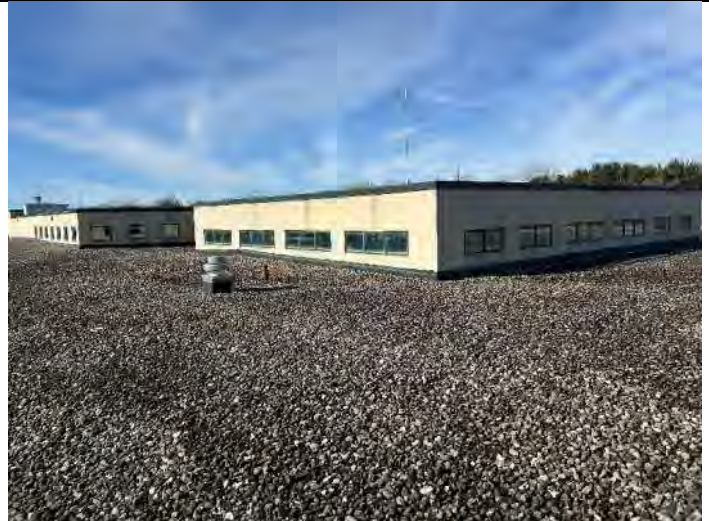
Elevation 12: EIFS is thin and needs cleaning.
